Hazardous Construction Materials Survey

St John of God Richmond Hospital

177 Grose Vale Road, North Richmond NSW

27 July 2022

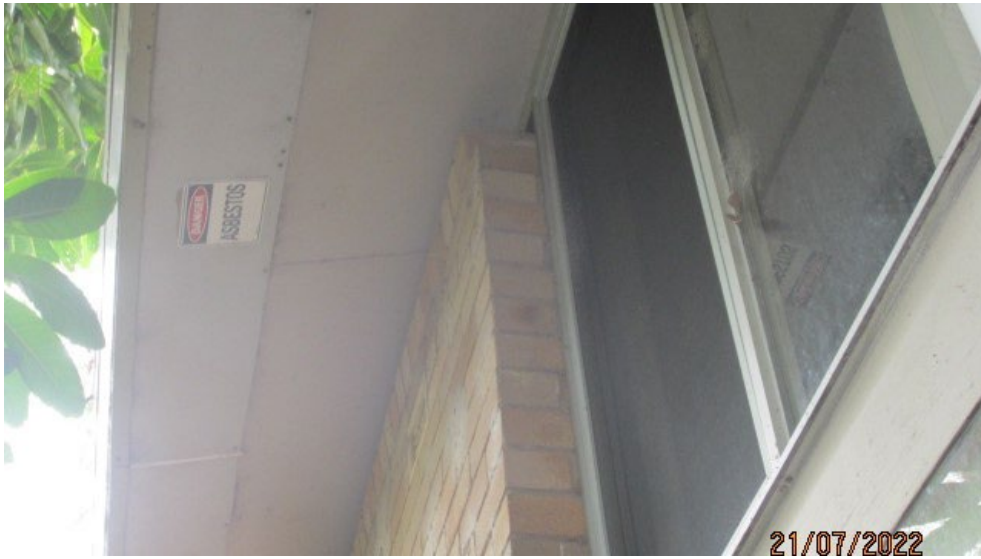
Photograph No. 1: Flat asbestos cement sheet eave lining in the CTC Building

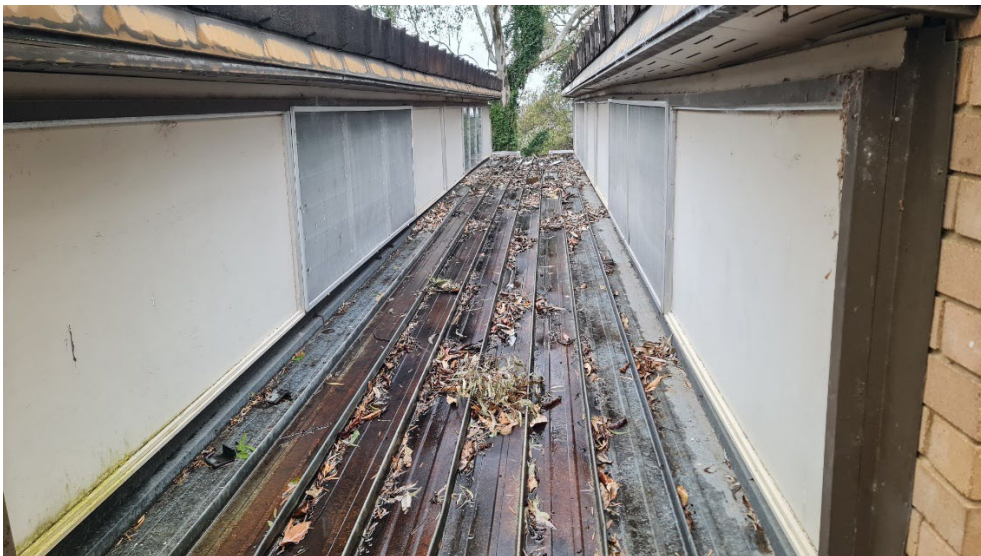
Over most of the centre flat roof area is a high level curved steel framed roof structure that has polycarbonate roof cladding. Infill panels to the high level windows along this area are flat asbestos cement sheet. See photograph No. 2. A sample of this infill material was analysed and found to contain chrysotile asbestos.

Photograph No. 2: Flat asbestos cement sheet infill panels and eave lining in the centre roof area of the CTC Building

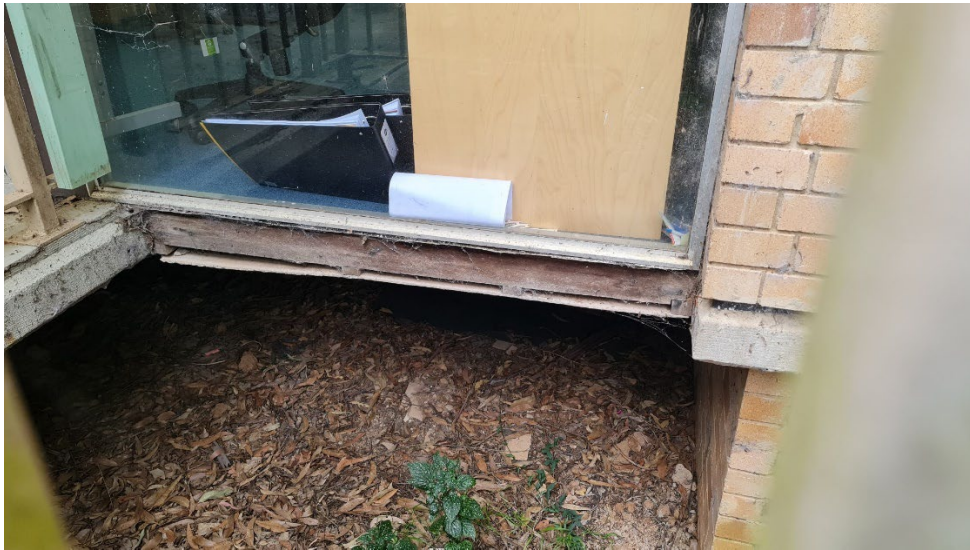
Photograph No. 3: Flat asbestos cement sheet below floor of the St Raphaels unit on the south east side of the CTC Building

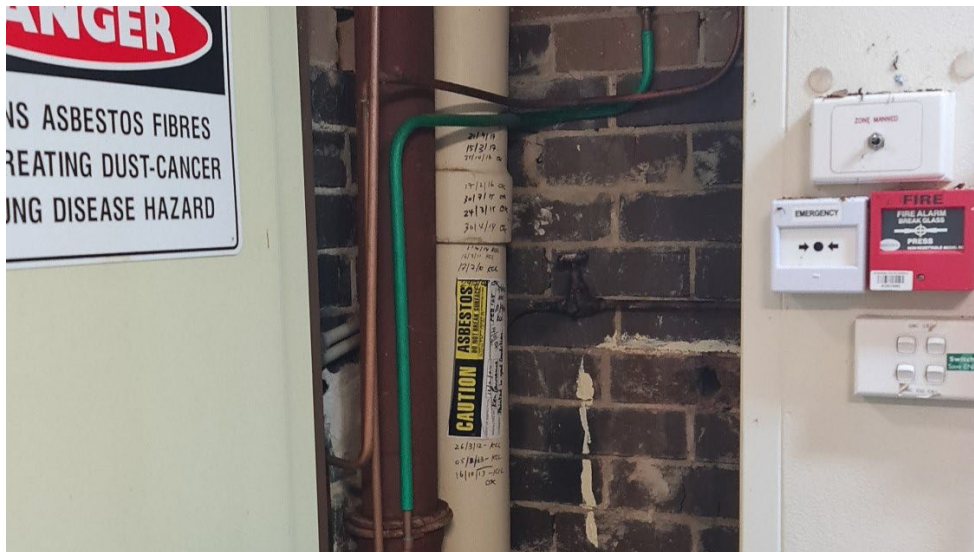
Within each of the bathrooms there are plumbing ducts that contain hot and cold water pipes, waste and vent pipework. In two of the ducts (Ducts 5 and 6) there are moulded asbestos cement flue pipes extending from the basement. See photograph No. 4. Hot water pipe work is generally insulated with green coloured plastic sheathing. No asbestos pipe insulation was sighted in these plumbing ducts. Former openings in the walls of these ducts located in the bathrooms have been covered with small panels of fibrous cement sheet. A sample of this material was analysed and found to be free of asbestos. A number of these panels have asbestos warning labels or handwriting warning of asbestos on them on the inner duct side. See photograph No. 6.

Photograph No. 4: Asbestos cement flue in Duct 6 in CTC Building

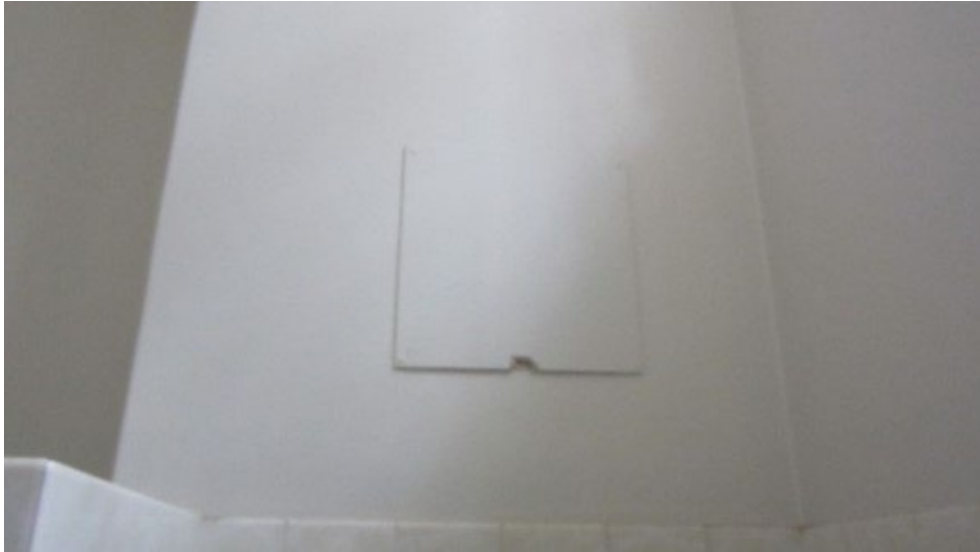
Photograph No. 5: Asbestos free fibrous cement sheet infill panel on plumbing duct in typical bathroom in CTC Building

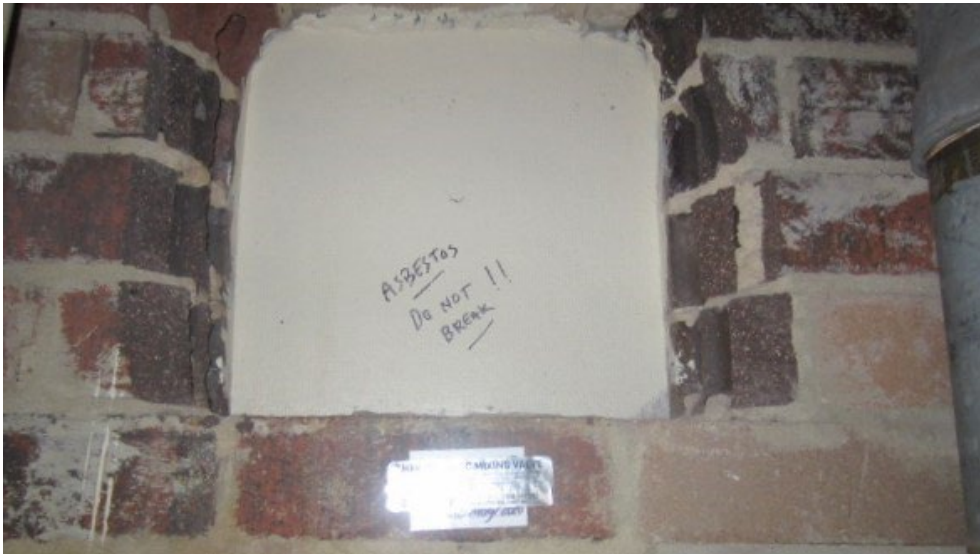
Photograph No. 6: Rear side of typical asbestos free fibrous cement sheet infill panel on plumbing duct in typical bathroom in CTC Building. A sample of this material was analysed and found to be free of asbestos

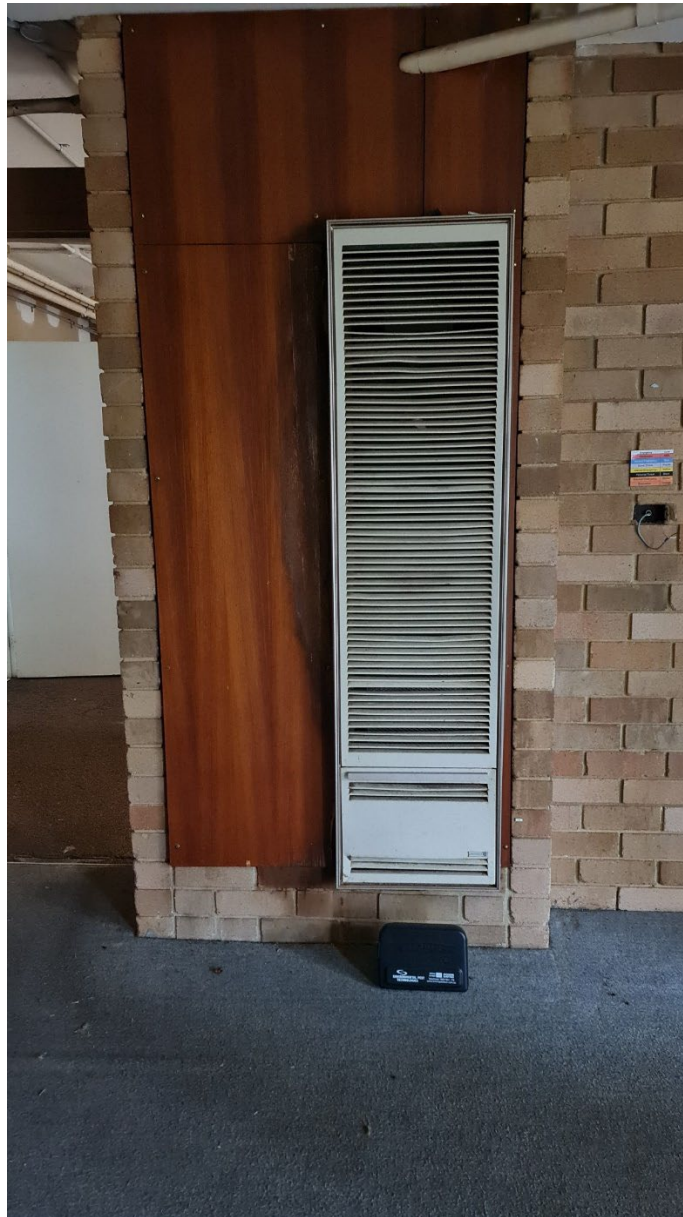
**Photograph No. 7: Gas room heater in gymnasium in the lower level of the CTC Building.
The flue attached to this heater is moulded asbestos cement**

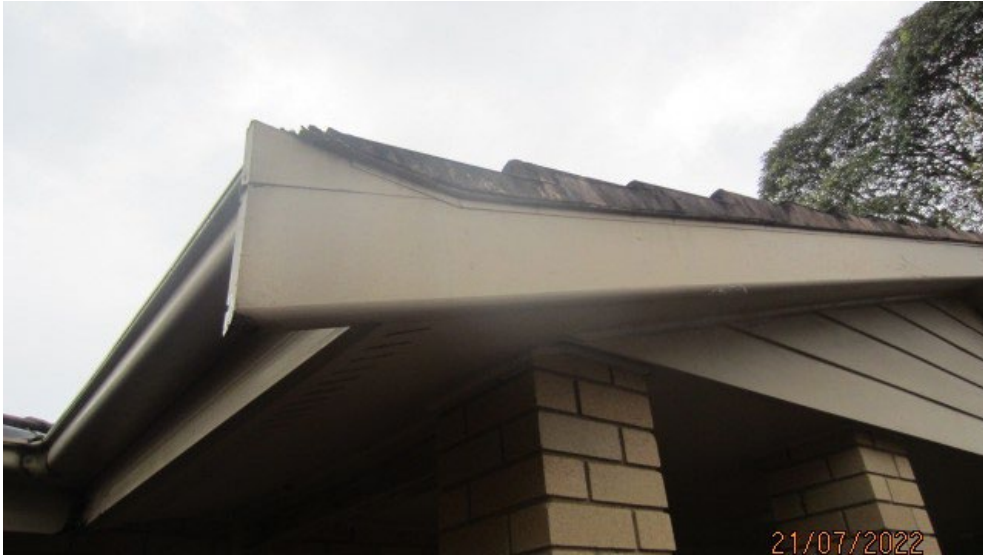
A sample of the fibrous cement sheet supporting strip material below the verge tiles along the gable roof ends at the north western Medical Centre end of the building (near the chapel) was analysed and found to be free of asbestos. See photograph No. 8.

A sample of the fibrous cement sheet eave lining material at the north western Medical Centre end of the building (near the chapel) was analysed and also found to be free of asbestos. See photograph No. 8.

**Photograph No. 8: Asbestos free fibrous cement sheet eave lining and verge tile supporting strip on the north west end of the Medical Services building.
The gable weatherboard cladding is hardboard 'Weathertex'**

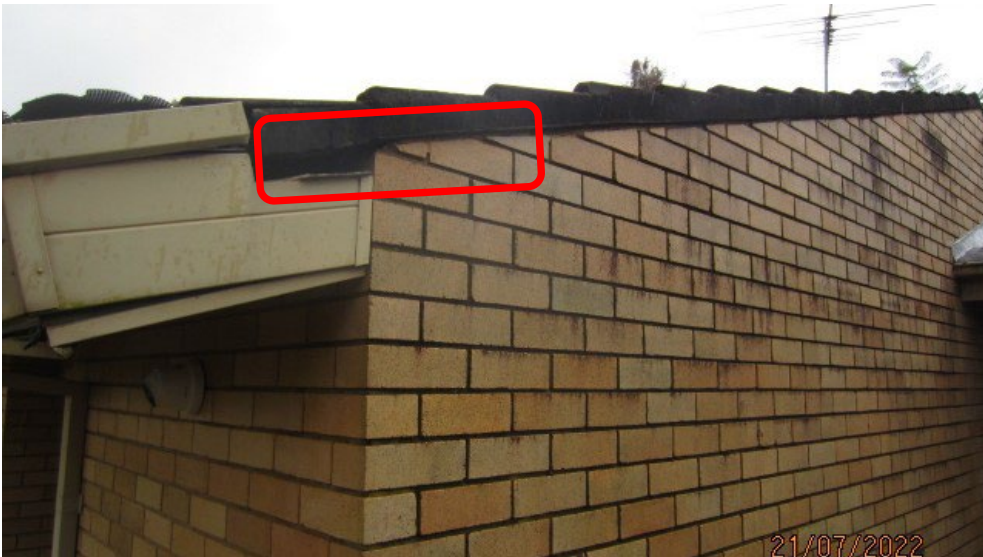
A sample of the upper asbestos cement sheet material below the roof tiles (anti ponding boards and below verge tiles) was analysed and found to contain chrysotile asbestos. See photograph No. 9. The lower eaves linings is also asbestos cement sheet.

Photograph No. 9: Asbestos cement sheet supporting strip below verge tiles and upper eave / anti-ponding board below lowest row of roof tiles on the Consulting Rooms building

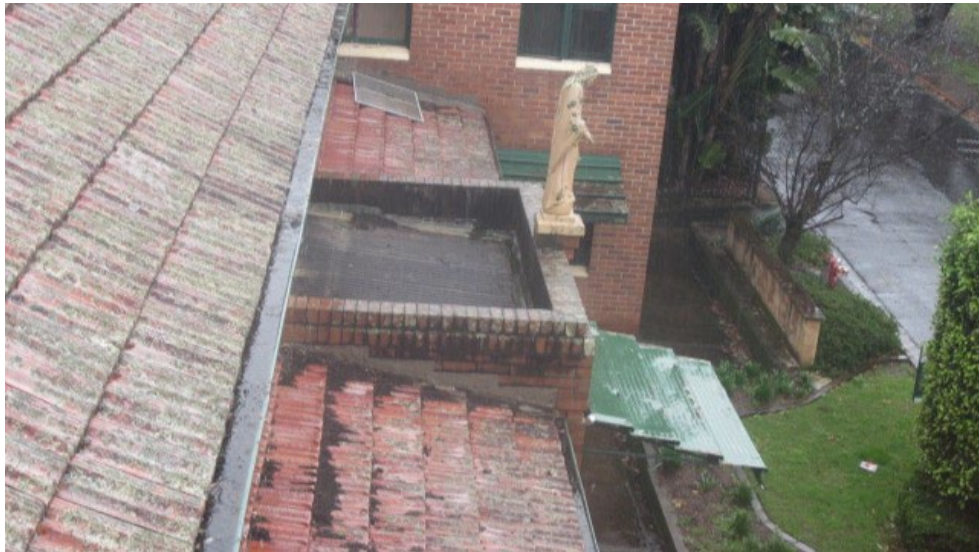
Photograph No. 10: Corrugated asbestos cement sheet roof cladding over front entry area to the Monastery building

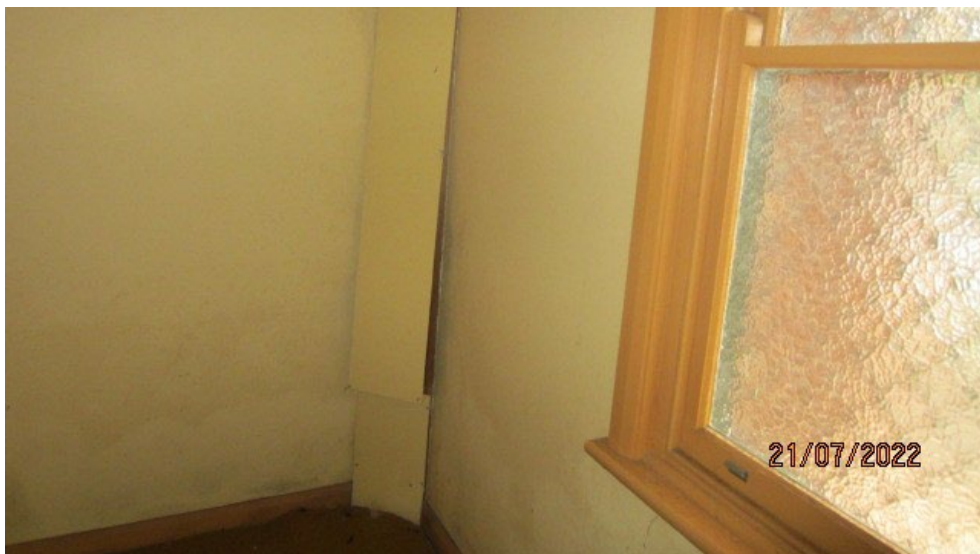
A sample of the fibrous cement sheet cover panel over the corner services duct in the ground level room adjacent to the front entry door was analysed and found to be free of asbestos. See photograph No. 11.

Photograph No. 11: Fibrous cement cover panels to service duct in front room in the Monastery building. A sample of this material was analysed and found to be free of asbestos

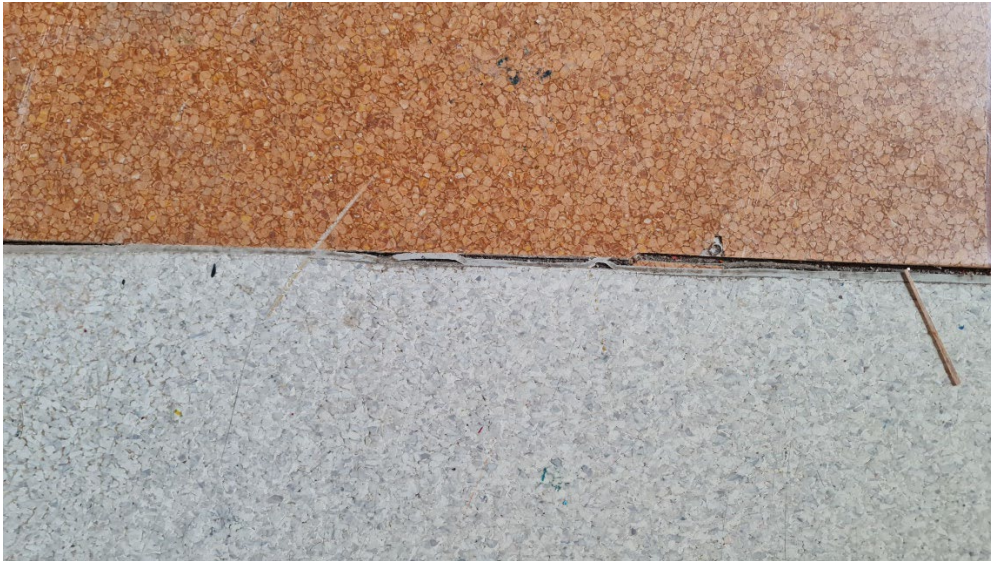
Floor finishes include carpet, sheet vinyl and ceramic tile. Within the large rear arts room, there is a mottled orange / brown coloured sheet vinyl covering the floor. A sample of this vinyl was found to have chrysotile asbestos in the paper backing layer. The grey coloured sheet vinyl in the rear kitchen area was analysed and found to be free of asbestos. See photograph No. 12.

Photograph No. 12: Orange / brown coloured sheet vinyl in rear room of the Arts Building. This vinyl was analysed and found to have asbestos in the fibrous backing layer. This material is classifiable as friable asbestos

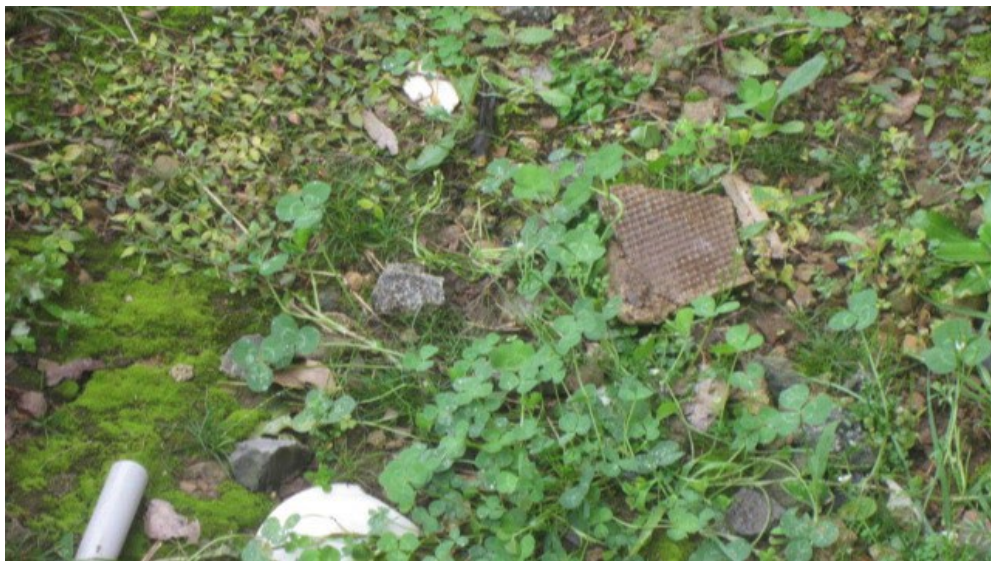
Photograph No. 13: Piece of asbestos cement sheet debris on the grassed ground area behind the Arts Building
