22 August 2022

**RE: ANALYSIS OF SUSPECTED ASBESTOS CONTAINING MATERIAL  
MONASTERY BUILDING AT ST JOHN OF GOD RICHMOND HOSPITAL  
177 GROSE VALE ROAD, NORTH RICHMOND NSW**

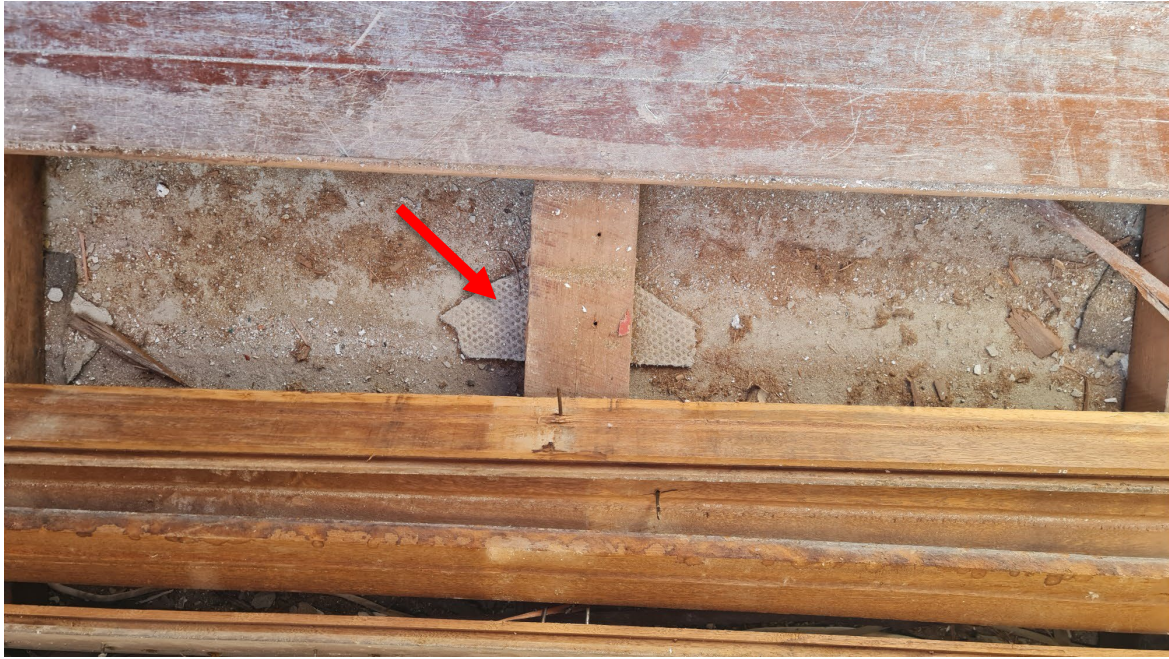
**PHOTOGRAPH**

Sample 1, Asbestos cement sheet packing material – **Chrysotile asbestos detected, amosite asbestos detected.**

This material is classifiable as non-friable asbestos for the purpose of asbestos removal.

**Asbestos cement packing piece between timber floor joist and concrete floor in the upper level of the Monastery Building. This material contains chrysotile asbestos and amosite asbestos**

The removal of the remaining floor boards within the building may be carried out by the persons that have been engaged to complete this work, albeit they are not formally trained in non-friable asbestos removal work. For the remainder of this work, the methodology detailed below is to be followed:

4. For the removal of the floor boards, the tools used to lift the boards are to be used in the centre area between each of the joists to minimise the likelihood of damaging the asbestos cement packing pieces.

5. During the floor board removal work, the asbestos supervisor is to inspect the concrete floor as the board are removed to identify loose pieces of asbestos cement sheet which are to be collected and bagged for disposal as asbestos waste.

6. Should any pieces of the asbestos cement sheet packing be broken during the work, these pieces are to be collected and the concrete floor wet wiped or vacuum cleaned to remove small pieces of debris.

7. At the completion of the floor board removal work all of the tools used in this work are to be cleaned to remove dust from the work.
8. Following removal of all of the floor boards and the timber joists, the asbestos removal contractor is to collect all remaining pieces of asbestos cement packing. The concrete floor is to then be vacuum cleaned to remove all remaining dust and debris.

9. A visual inspection is inspection is to be carried out at the completion of the work to verify that all of the asbestos cement sheet packing has been removed and the areas within the building may be opened for demolition work and other access without the use of asbestos PPE.
