21 August 2022

**RE: ANALYSIS OF SUSPECTED ASBESTOS CONTAINING MATERIAL
MONASTERY BUILDING AT ST JOHN OF GOD RICHMOND HOSPITAL
177 GROSE VALE ROAD, NORTH RICHMOND NSW**

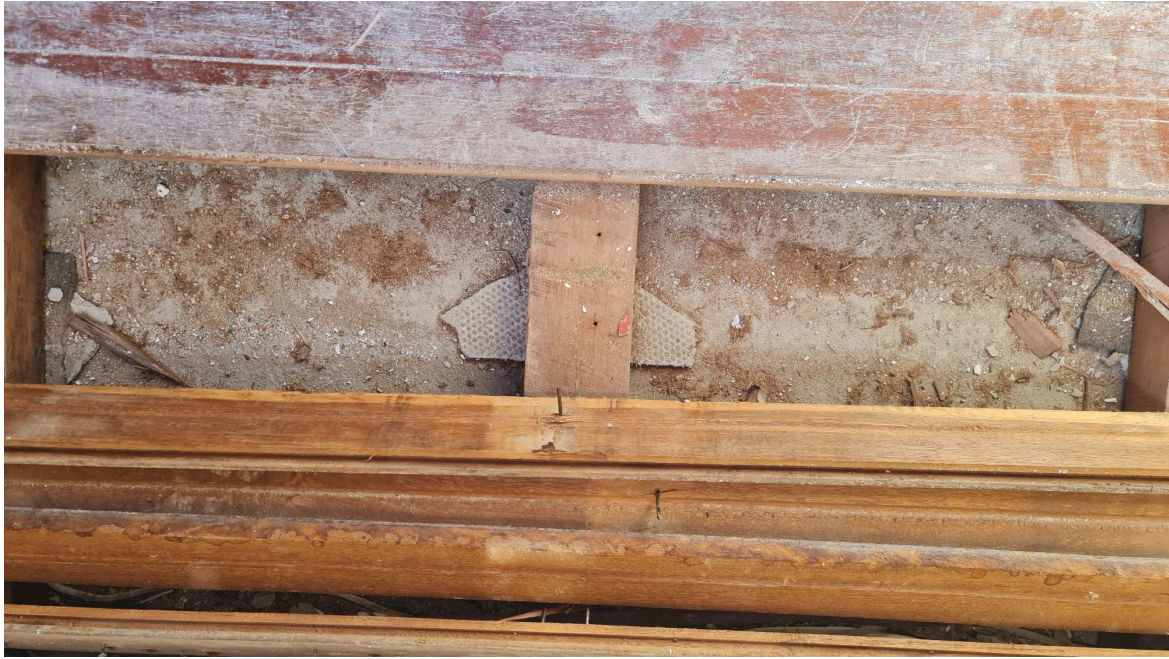
Sample 1, Asbestos cement sheet packing material – **Chrysotile asbestos detected.**

This material is classifiable as non-friable asbestos for the purpose of asbestos removal.

Asbestos cement packing piece between timber floor joist and concrete floor in the upper level of the Monastery Building. This material contains chrysotile asbestos

The removal of the remaining floor boards within the building may be carried out by the persons that have been engaged to complete this work, albeit they are not formally trained in non-friable asbestos removal work. For the remainder of this work, the methodology detailed below is to be followed:

4. For the removal of the floor boards, the tools used to lift the boards are to be used in the centre area between each of the joists to minimise the likelihood of damaging the asbestos cement packing pieces.

5. During the floor board removal work, the asbestos supervisor is to inspect the concrete floor as the board are removed to identify loose pieces of asbestos cement sheet which are to be collected and bagged for disposal as asbestos waste.

6. Should any pieces of the asbestos cement sheet packing be broken during the work, these pieces are to be collected and the concrete floor wet wiped or vacuum cleaned to remove small pieces of debris.

7. At the completion of the floor board removal work all of the tools used in this work are to be cleaned to remove dust from the work.
8. Following removal of all of the floor boards and the timber joists, the asbestos removal contractor is to collect all remaining pieces of asbestos cement packing. The concrete floor is to then be vacuum cleaned to remove all remaining dust and debris.

9. A visual inspection is inspection is to be carried out at the completion of the work to verify that all of the asbestos cement sheet packing has been removed and the areas within the building may be opened for demolition work and other access without the use of asbestos PPE.
