RE: ASBESTOS AND STOCKPILING OF FILL SOIL CONTAINING ASBESTOS CEMENT SHEET DEBRIS FROM THE EDUCATION CENTRE DEMOLITION AREA AT THE ST JOHN OF GOD RICHMOND HOSPITAL, 177 GROSE VALE ROAD, NORTH RICHMOND NSW

PCA7420-2022_LET15_1Nov22

PHOTOGRAPH

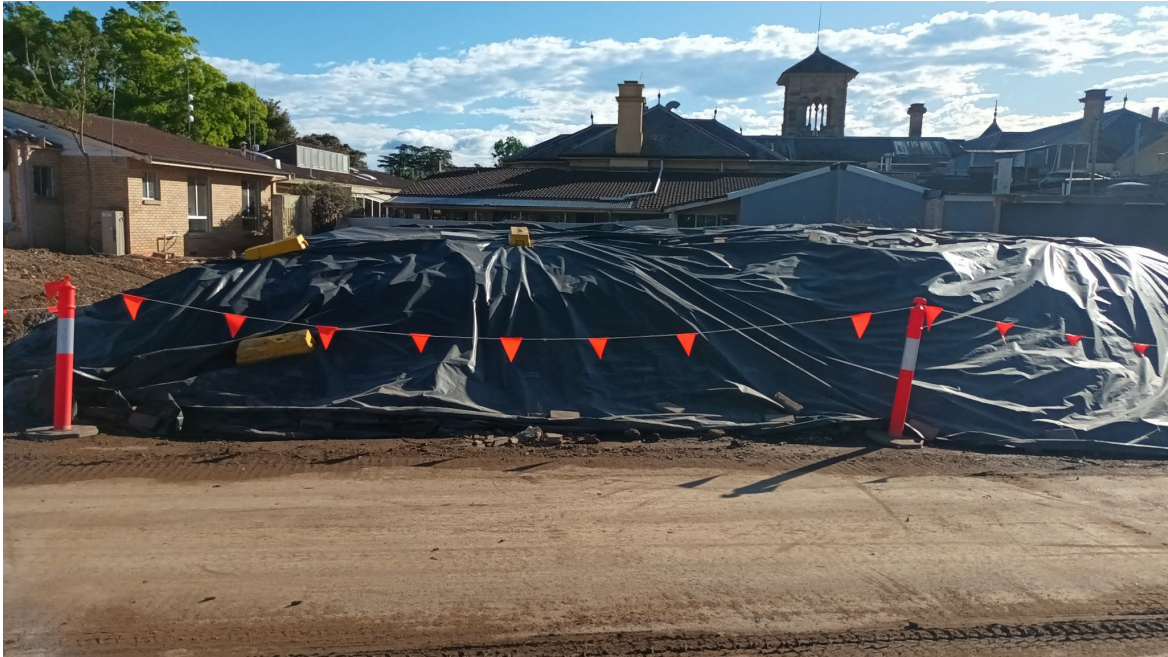
The asbestos contaminated soil that has been removed from this area has been placed into a stockpile located near the centre road and is covered with black plastic. There is an estimated 200 – 210 cubic metres of asbestos contaminated fill soil in this stockpile. See attached photograph.

Excavated soil containing asbestos cement sheet debris from the Education Centre area that was stockpiled on 26 October 2022
