RE: REMOVAL OF ASBESTOS CONTAMINATED CONCRETE AND DEBRIS IN THE LOCATION OF THE FORMER EDUCATION CENTRE BUILDING AT ST JOHN OF GOD RICHMOND HOSPITAL, 177 GROSE VALE ROAD, NORTH RICHMOND NSW

We refer to our visual inspection and asbestos material sample collection undertaken on Friday 2 September 2022 following the discovery of asbestos cement sheet debris embedded in the underside of the concrete floor slab of the Education Centre Building located within the St John of God Richmond Hospital at 177 Grose Vale Road, North Richmond NSW (the site).

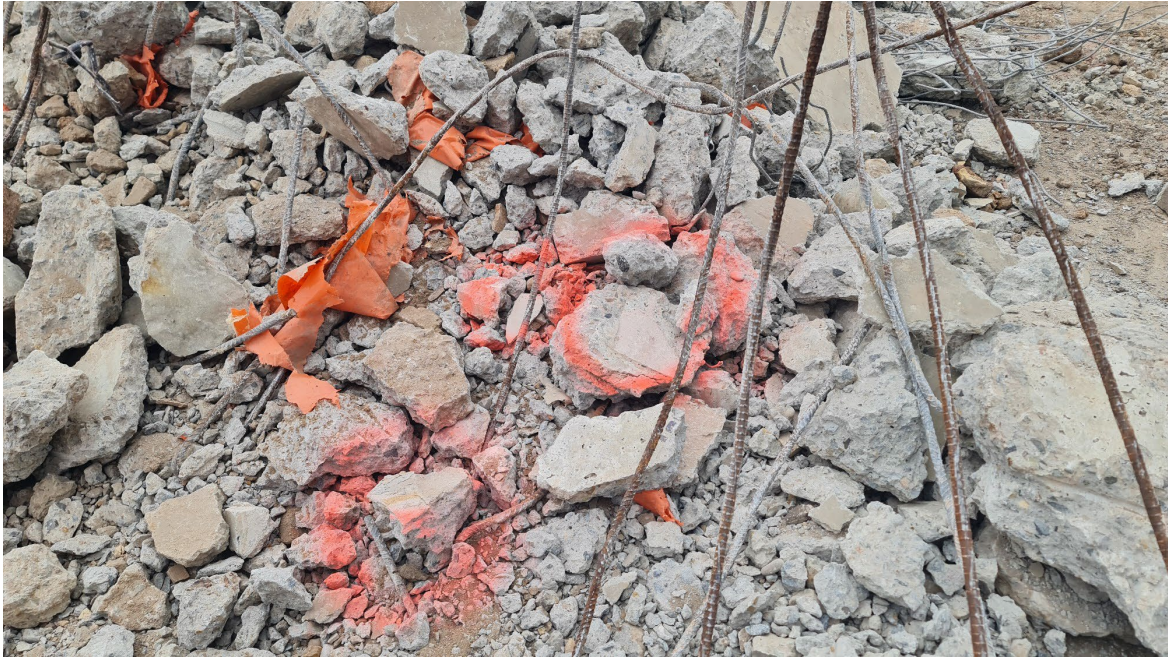
During demolition of the concrete floor slab, pieces of asbestos cement sheet have been found embedded at regular intervals in the underside of the concrete slab which are presumed to be support chairs for the reinforcing steel within the slab. Upon removal of parts of the slab, loose pieces of asbestos cement sheet have been found on the ground surface below the slab.

Analysis of the sampled material confirmed it to contain chrysotile asbestos. See sample 2 on the attached laboratory report.

**Asbestos cement sheet material embedded on concrete floor slab
of the Education Centre building – Contains chrysotile asbestos**

5. The concrete slab pieces with embedded asbestos cement sheet debris is to be broken up and loaded into plastic lined skip bins or trucks and transported for disposal as non-friable asbestos contaminated waste at a landfill facility licenced by the NSW EPA to accept the waste soil.

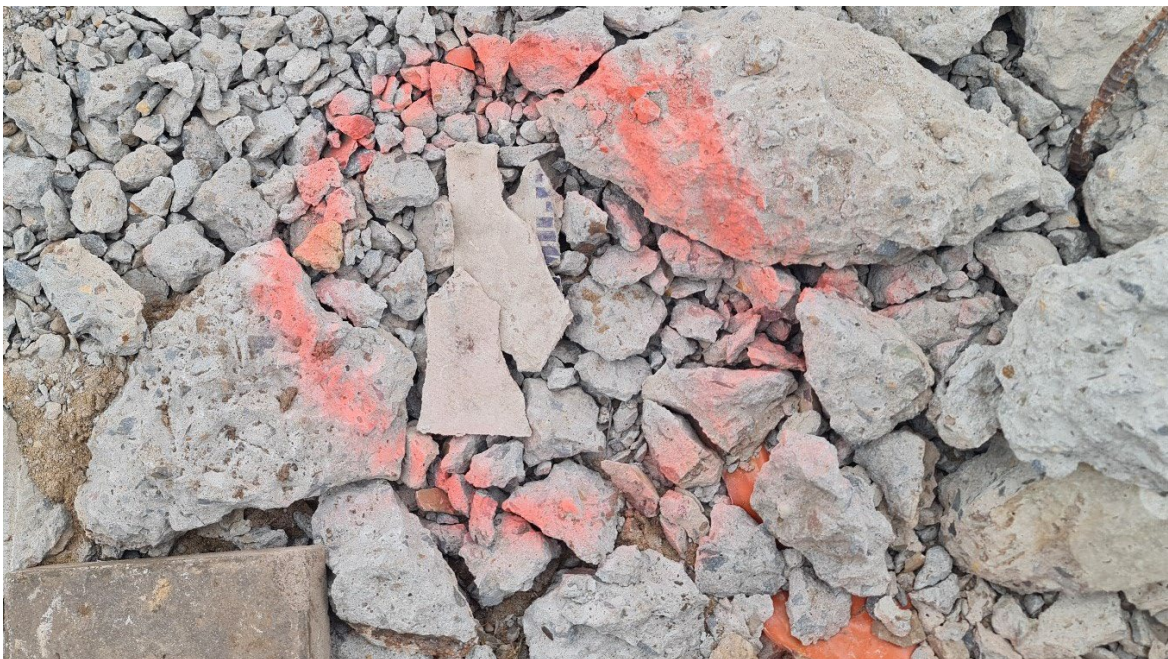
**Asbestos cement sheet material found below concrete floor slab
of the Education Centre building – Contains chrysotile asbestos**

6. After all of the concrete has been removed, the loose fragments of asbestos cement sheet debris are to be collected and bagged for disposal as asbestos waste.

7. The fill soil containing fragments of asbestos cement sheet debris and concrete debris is to be scrapped to remove all concrete and asbestos cement sheet debris.
