24 October 2022

**RE: REMOVAL OF ASBESTOS CONTAMINATED CONCRETE AND DEBRIS IN
THE AREA BETWEEN THE MEDICAL CENTRE BUILDING AND CTC BUILDING,
INCLUDING THE FOOD SERVICES UNIT AREA AT ST JOHN OF GOD
RICHMOND HOSPITAL, 177 GROSE VALE ROAD, NORTH RICHMOND NSW**

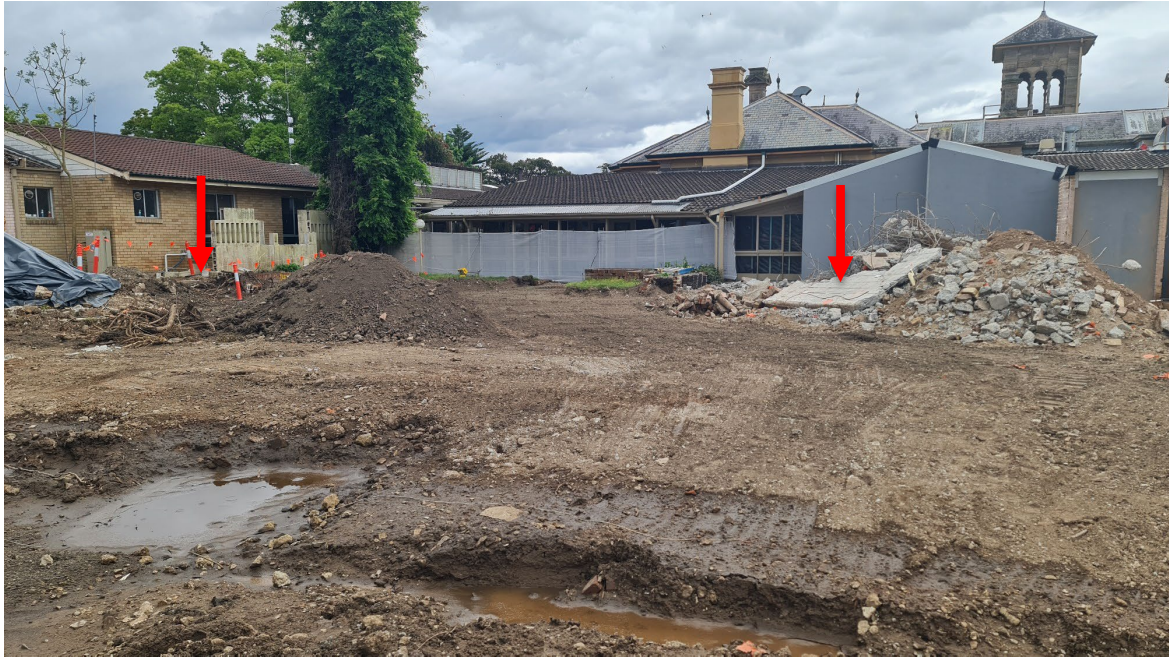
Area adjacent to the Medical Centre Building and area on which the former Food Services Unit Building was located where asbestos cement sheet debris has been recently identified

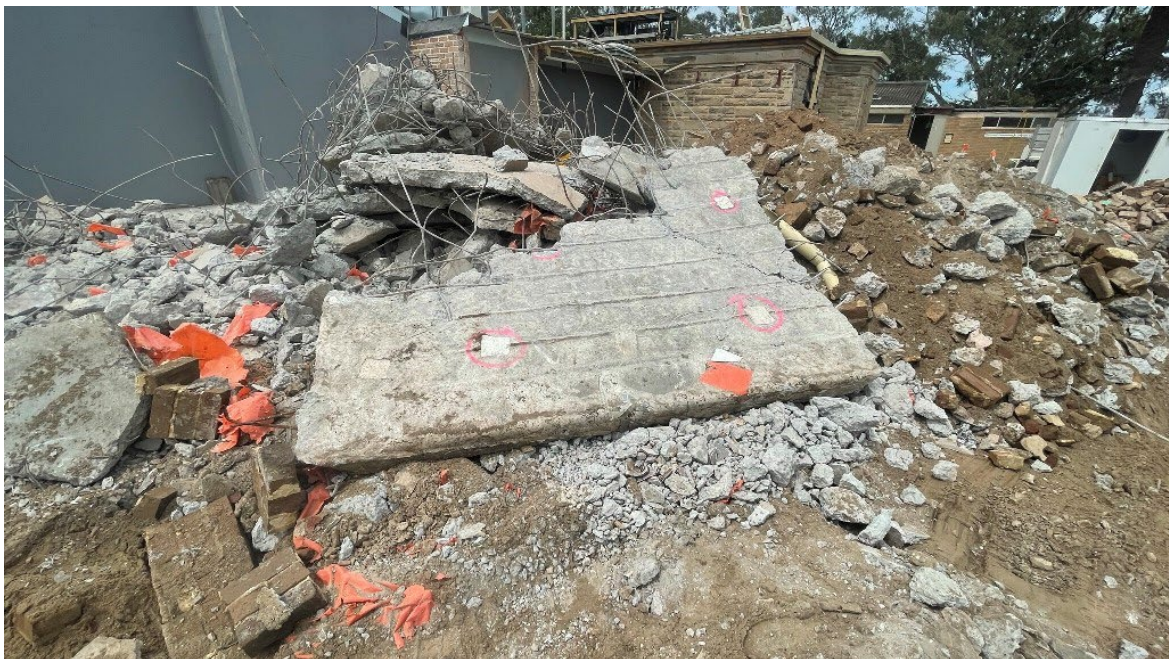
1. Fibro cement sheet debris from the concrete floor slab of the Food Services Unit, north area – **Chrysotile asbestos, amosite asbestos and crocidolite asbestos detected.**
2. Fibro cement sheet debris from below the concrete floor slab of the Food Services Unit, south area – **Chrysotile asbestos detected.**
3. Fibro cement sheet debris from fill soil adjacent to the Medical Centre Building – **Chrysotile asbestos, amosite asbestos and crocidolite asbestos detected.**

**Asbestos cement sheet material embedded on concrete floor slab
of the former Food Services Unit building – Contains chrysotile asbestos,
amosite asbestos and crocidolite asbestos**

6. The concrete slab pieces with embedded asbestos cement sheet debris is to be broken up and loaded into plastic lined skip bins or trucks and transported for disposal as non-friable asbestos contaminated waste at a landfill facility licenced by the NSW EPA to accept the waste soil.

7. After all of the concrete has been removed, the loose fragments of asbestos cement sheet debris are to be collected and bagged for disposal as asbestos waste.

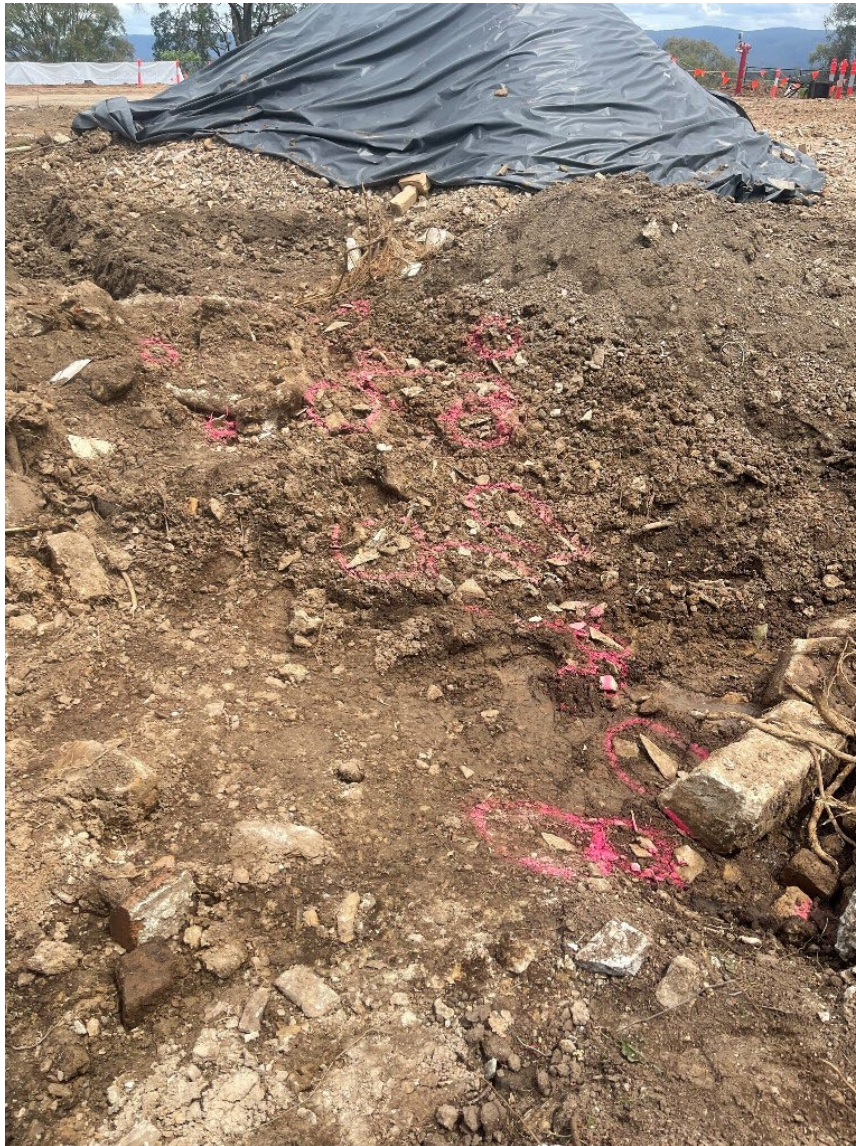
**Asbestos cement sheet material found in fill soil near the
Medical Centre Building – Contains chrysotile asbestos**

8. The fill soil containing fragments of asbestos cement sheet debris and concrete debris is to be scrapped to remove all concrete and asbestos cement sheet debris.
