**RE: ANALYSIS OF BITUMEN MEMBRANE PAINT ON BRICK WALLS OF IN-GROUND WATER TANK BELOW MEDICAL CENTRE BUILDING AT THE ST JOHN OF GOD RICHMOND HOSPITAL, 177 GROSE VALE ROAD, NORTH RICHMOND NSW**

**PHOTOGRAPH**

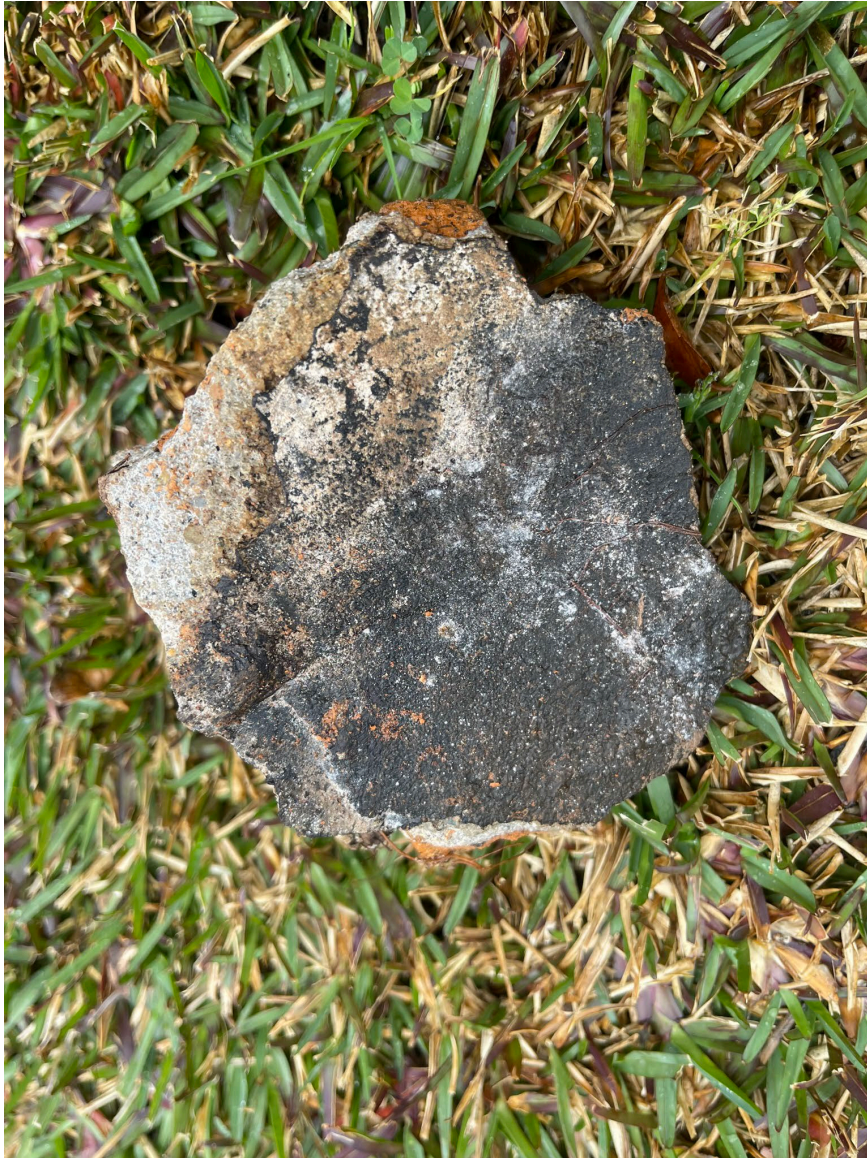
Sample 1, Black bitumen paint on brick wall of in-ground water tank – No asbestos detected.

**Bitumen waterproofing paint on brick from in-ground water storage tank in the area where the Medical Centre building was located.  
This material was analysed and found to be free of asbestos**
