22 August 2022

RE: REMOVAL OF ASBESTOS CONTAMINATED FILL SOIL IN THE FORMER TENNIS COURT / NEW WELLNESS CENTRE AREA AT ST JOHN OF GOD RICHMOND HOSPITAL AT 177 GROSE VALE ROAD, NORTH RICHMOND NSW

AERIAL PHOTOGRAPH

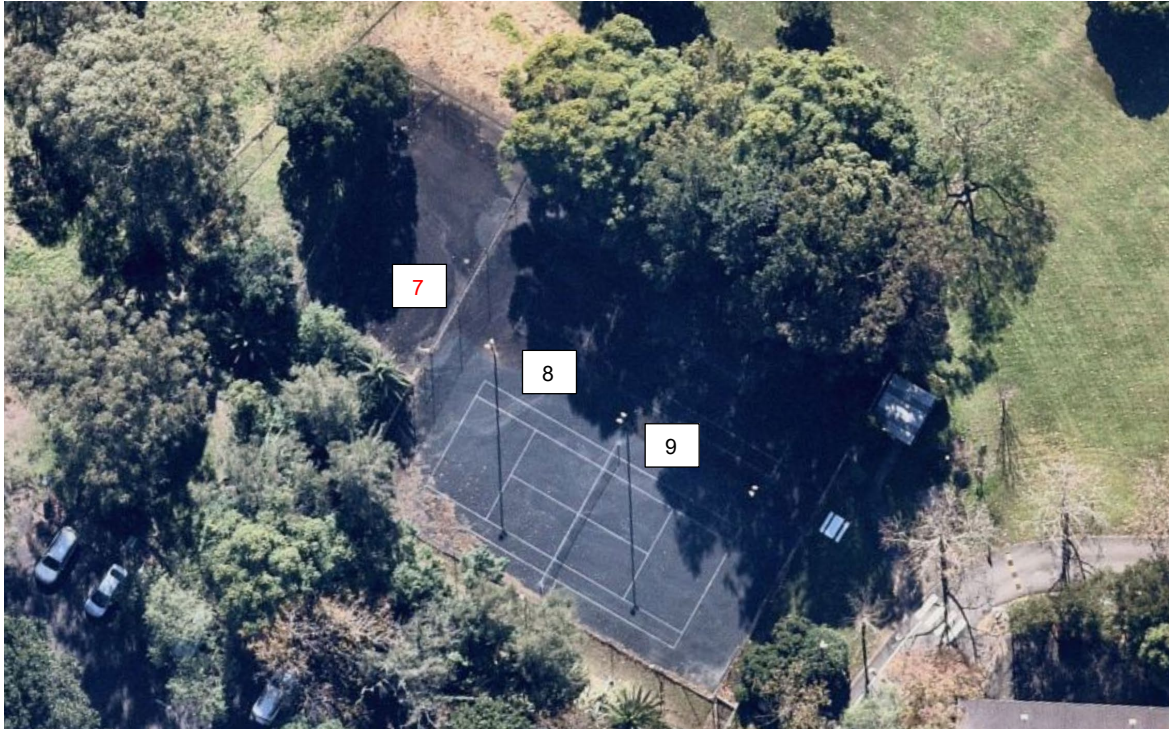
Aerial photograph of the former tennis court area at 177 Grose Vale Road, North Richmond NSW showing the asbestos soil sample locations that were collected on 18 August 2022.

Sample 7 in the north west part of the area contains chrysotile asbestos in the form of friable asbestos

The soil sample which was taken from the fill soil removed from TP 1 located in the north western part of the excavation area within the site was found to containing asbestos as AF / FA above the acceptance criteria of 0.001%. The asbestos material in this sample is classifiable as friable asbestos containing material.

Soil sample No. 7 that was collected from excavated fill soil in the former tennis court area of the site on 18 August 2022 for asbestos classification analysis was found to contain a small amount of fibrous asbestos material less than 7mm in size as asbestos fines (AF) and fibrous asbestos (FA). Asbestos in this form is classifiable as friable asbestos containing material.

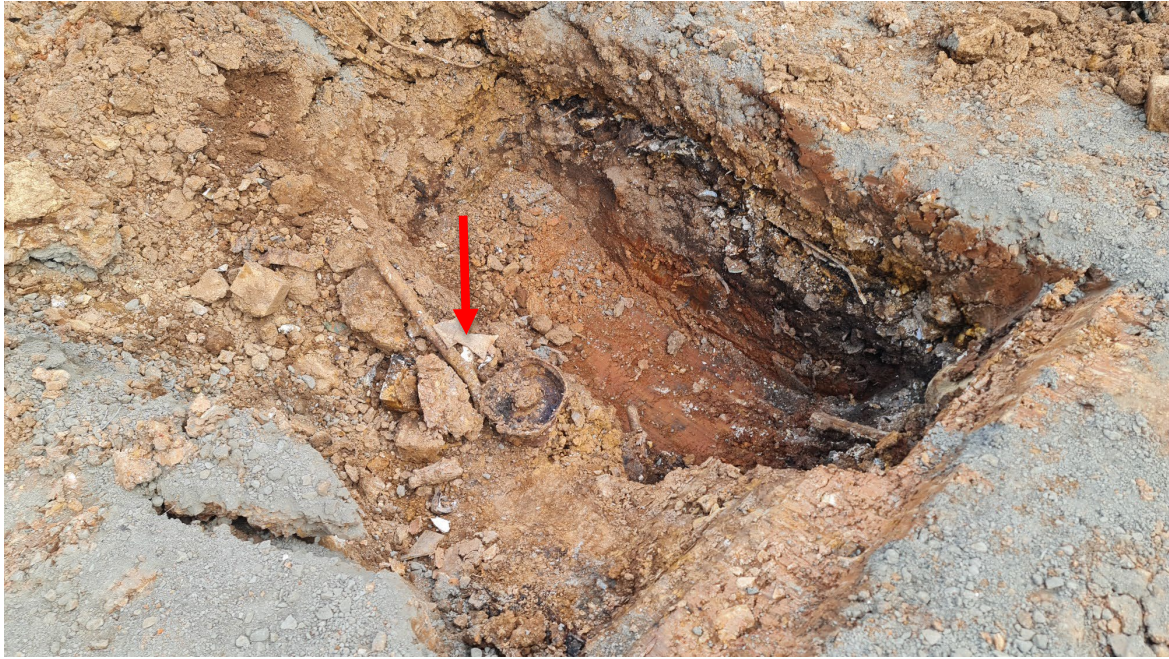
Fill soil in former tennis court area containing metal, glass and pieces of asbestos cement sheet debris. Arrow indicates asbestos cement sheet debris

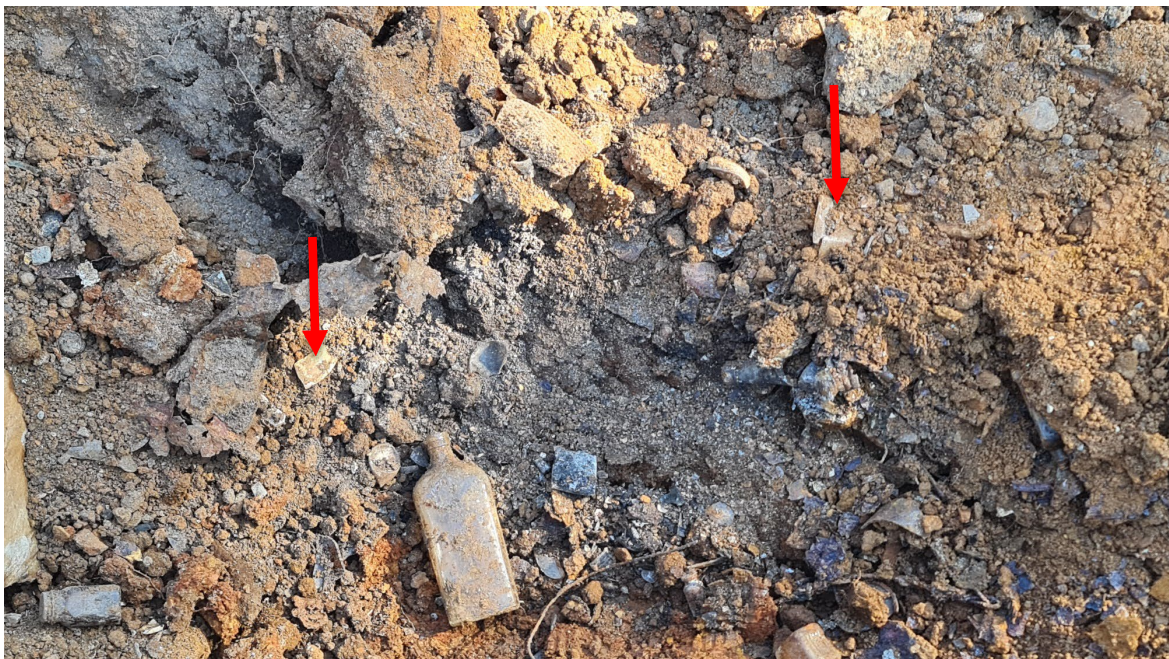
Fill soil in former tennis court area containing metal, glass and pieces of asbestos cement sheet debris. Arrows indicates asbestos cement sheet debris
