**RE: WASTE CLASSIFICATION OF IN-SITU FILL SOIL CONTAINING ASBESTOS CEMENT SHEET DEBRIS IN THE FORMER TENNIS COURT / NEW WELLNESS CENTRE AREA AT ST JOHN OF GOD RICHMOND HOSPITAL, 177 GROSE VALE ROAD, NORTH RICHMOND NSW**

This letter report presents the findings of a waste classification assessment conducted on in-situ fill soil that is to be excavated for off-site disposal from within the former tennis court was located within the St John of God Richmond Hospital at 177 Grose Vale Road, North Richmond NSW (the site). A new wellness centre is to be constructed in this area of the site.

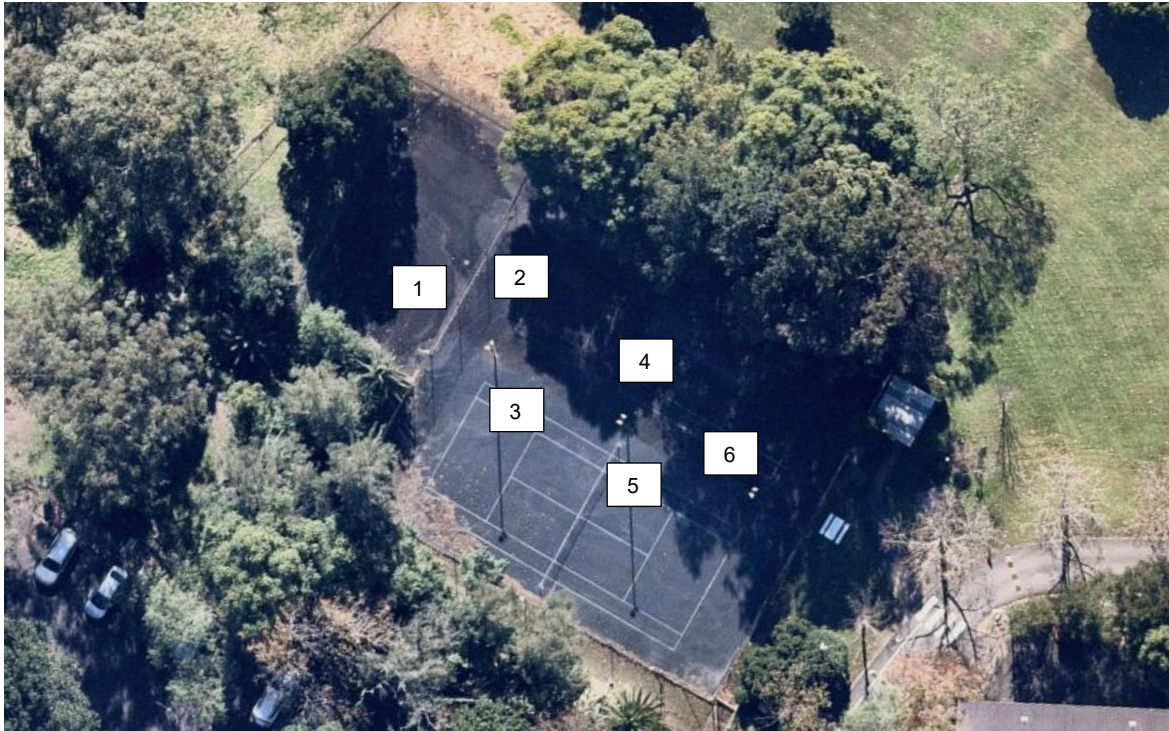
**AERIAL PHOTOGRAPH**

**Aerial photograph of the former tennis court area at 177 Grose Vale Road, North Richmond NSW showing the waste classification soil sample locations that were collected on 18 August 2022.**

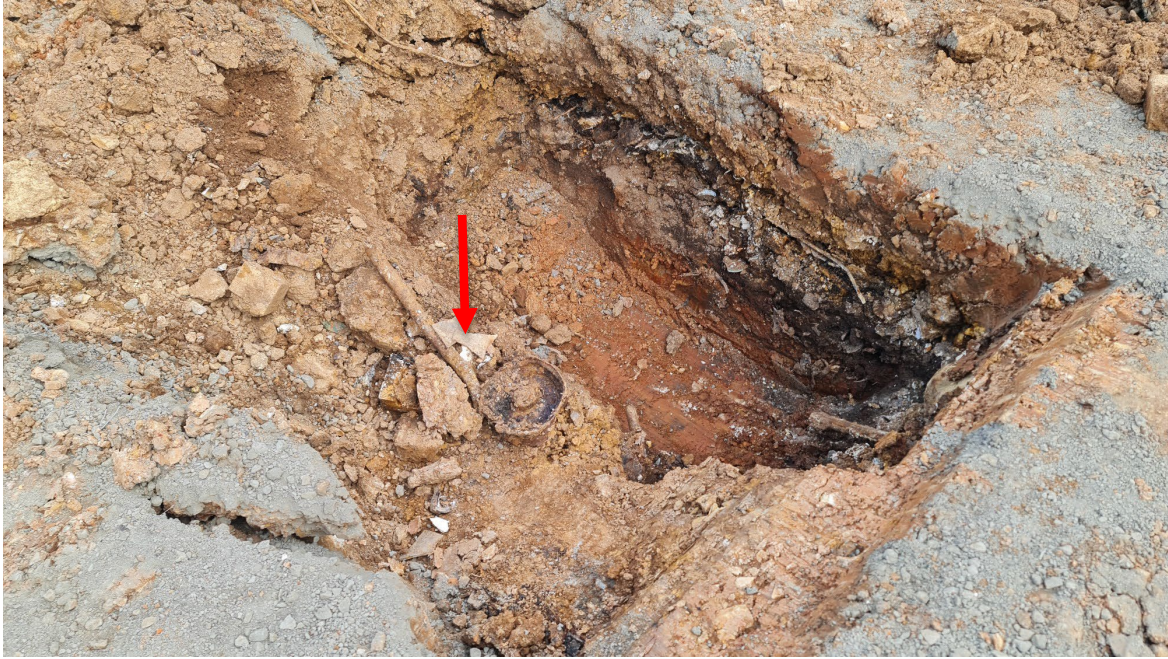
The fill soil comprises mostly red to orange / brown coloured sandy clay in which there are broken glass, steel, vehicle wheel rims, building debris and pieces of asbestos cement sheet debris. See attached photographs.

**Sandy clay fill soil in former tennis court area containing metal, glass and pieces of asbestos cement sheet debris. Arrow indicates asbestos cement sheet debris**

**As this soil contains friable asbestos material and fragments of asbestos cement sheet debris, this soil must only be disposed of at a landfill facility licenced by the NSW EPA to accept soils classified as general solid waste – special waste asbestos.**

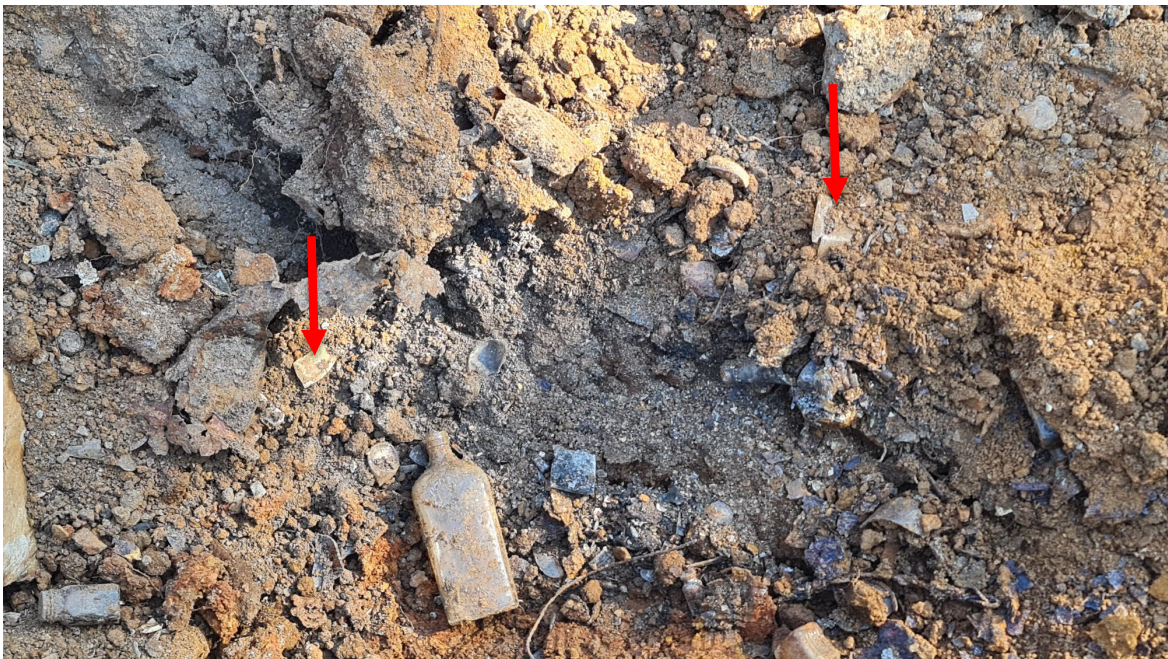
**Sandy clay fill soil in former tennis court area containing metal, glass and pieces of asbestos cement sheet debris. Arrows indicates asbestos cement sheet debris**
