**RE: ASBESTOS REMOVAL CLEARANCE CERTIFICATION FOR THE ASBESTOS
BACKED SHEET VINYL IN THE SOUTHERN AREA IN THE CTC BUILDING AT THE ST JOHN
OF GOD RICHMOND HOSPITAL, 177 GROSE VALE ROAD, NORTH RICHMOND NSW**

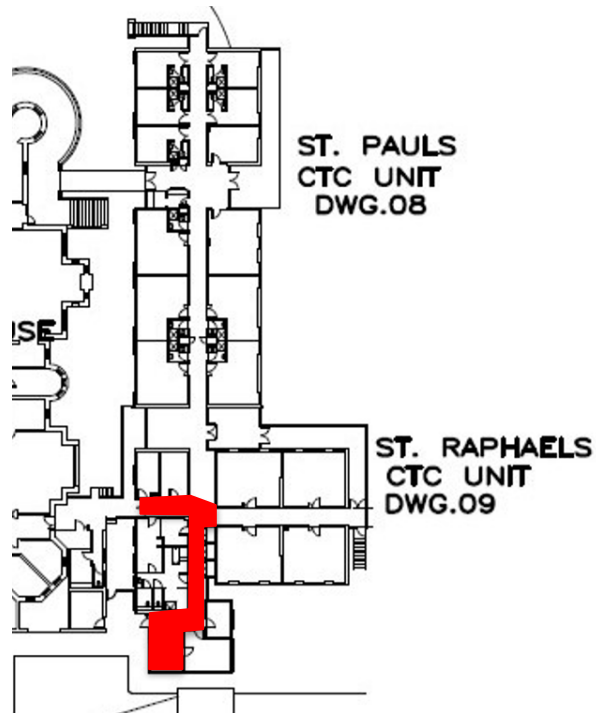
The visual inspection undertaken on 4 October 2022 found all of the asbestos backed sheet vinyl to have been fully removed from within the southern corridor area and the adjacent to rooms within the CTC Building. The areas where the vinyl was removed are shown in red on the attached floor plan.

Area in southern part of the CTC Building from which the removal of asbestos vinyl floor covering was completed on 4 October 2022 at the St John of God Richmond Hospital, 177 Grose Vale Road, North Richmond NSW

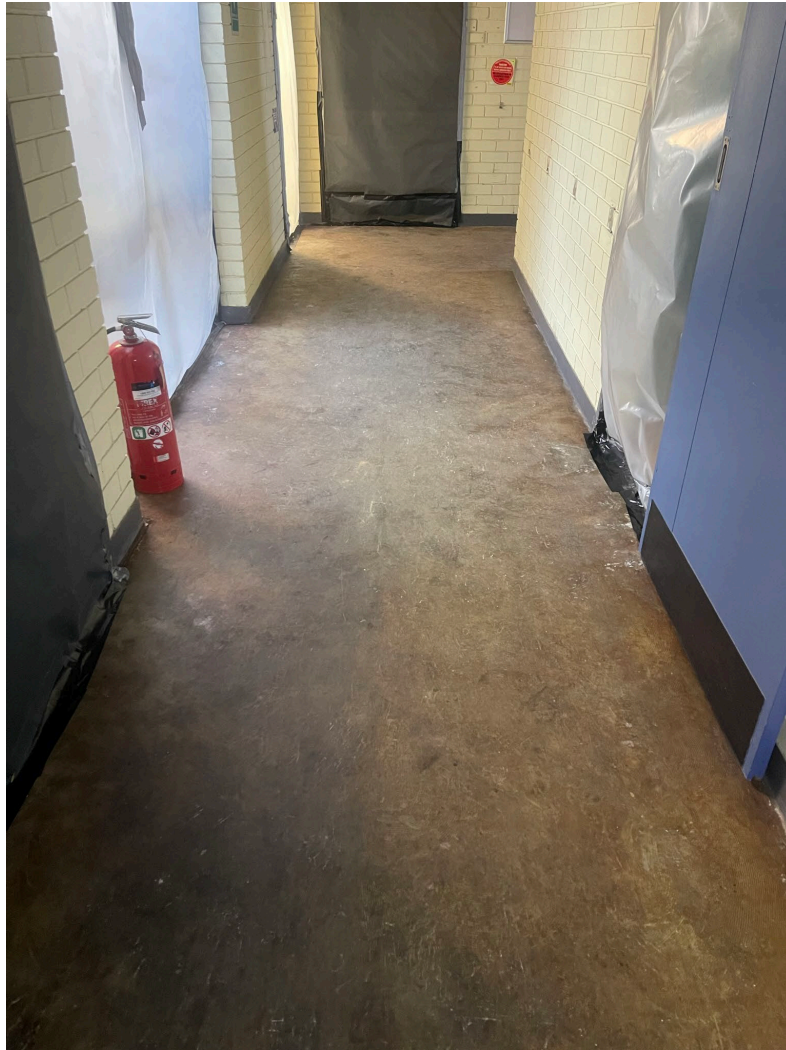
The concrete floor remaining in these areas in the building were found to be free of visible asbestos containing material debris from the work. See attached photographs.

Typical concrete floor in corridor in the southern part of the CTC Building at St John of God Richmond Hospital, 177 Grose Vale Road, North Richmond NSW at completion of visual clearance inspection on 4 October 2022

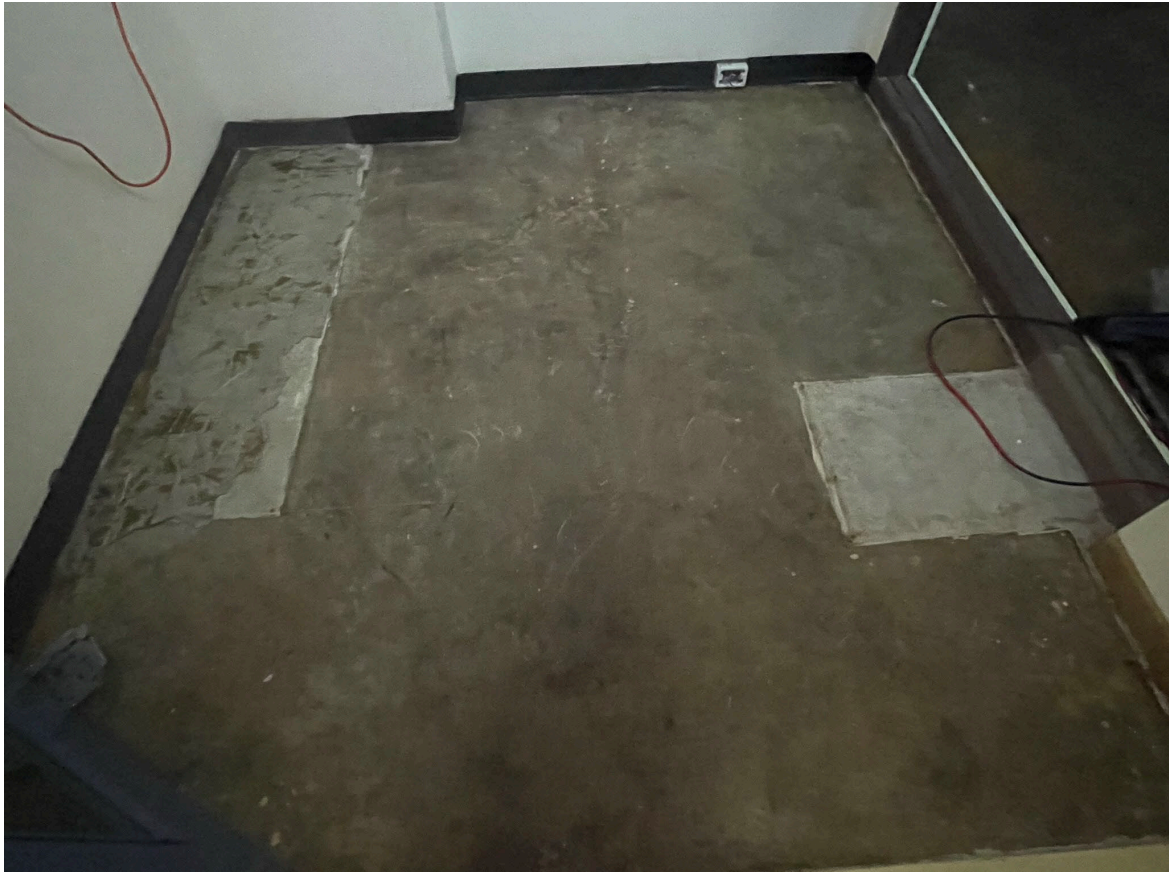
Typical concrete floor in a room in the southern part of the CTC Building at St John of God Richmond Hospital, 177 Grose Vale Road, North Richmond NSW at completion of visual clearance inspection on 4 October 2022
