12 October 2022

**RE: ASBESTOS REMOVAL CLEARANCE CERTIFICATION FOR THE ASBESTOS
BACKED SHEET VINYL IN THE EASTERN AREA IN THE CTC BUILDING AT THE ST JOHN
OF GOD RICHMOND HOSPITAL, 177 GROSE VALE ROAD, NORTH RICHMOND NSW**

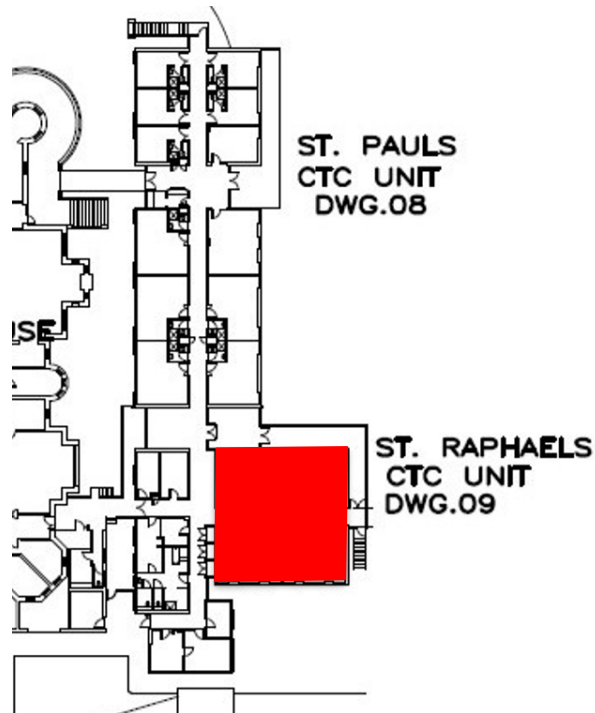
The visual inspection undertaken on 11 October 2022 found all of the asbestos backed sheet vinyl to have been fully removed from within the eastern part of the centre corridor area and the adjacent to rooms to the east within the CTC Building. The areas where the vinyl was removed are shown in red on the attached floor plan.

Area in eastern part of the CTC Building from which the removal of asbestos vinyl floor covering was completed on 11 October 2022 at the St John of God Richmond Hospital, 177 Grose Vale Road, North Richmond NSW

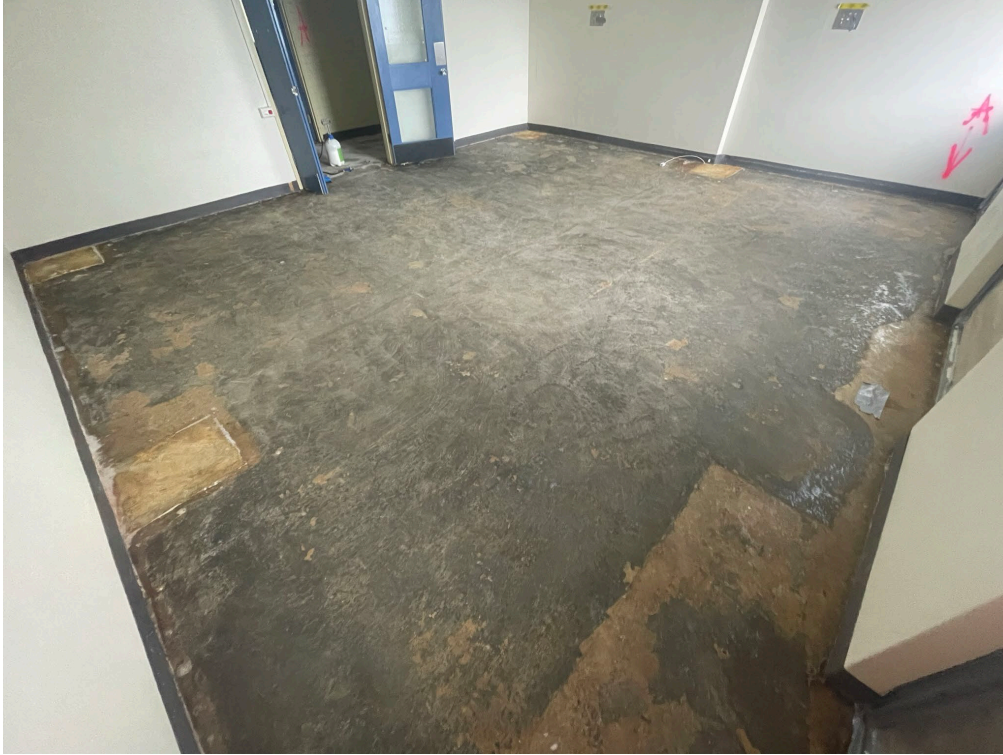
The concrete floor remaining in these areas in the building were found to be free of visible asbestos containing material debris from the work. See attached photographs.

Concrete floor in typical room in the eastern part of the CTC Building at St John of God Richmond Hospital, 177 Grose Vale Road, North Richmond NSW at completion of visual clearance inspection on 11 October 2022

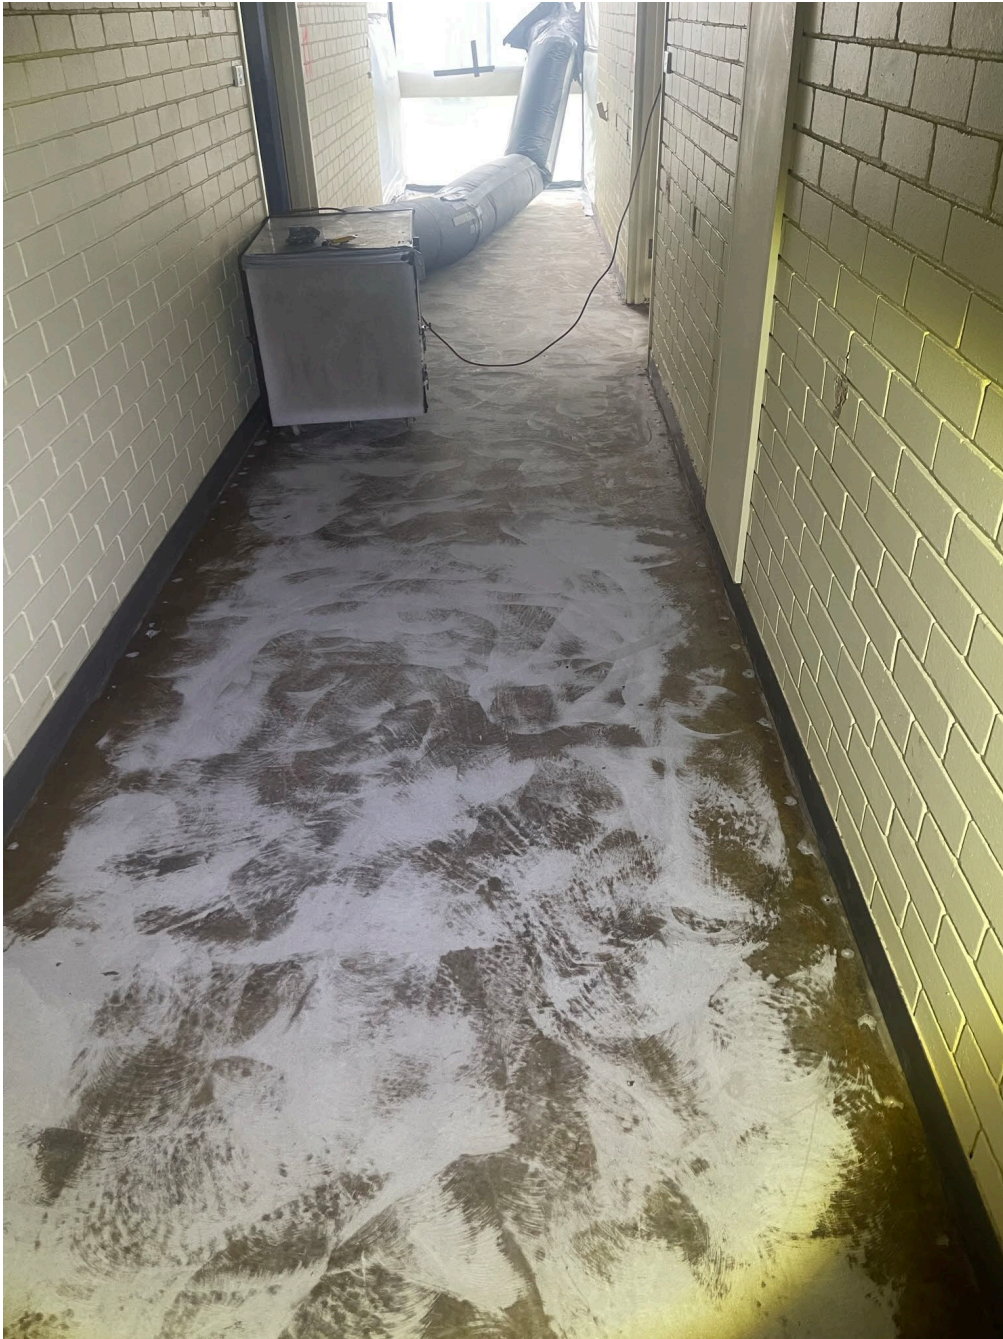
Concrete floor in corridor in the eastern part of the CTC Building at St John of God Richmond Hospital, 177 Grose Vale Road, North Richmond NSW at completion of visual clearance inspection on 11 October 2022
