5 September 2022

RE: ANALYSIS OF SUSPECTED ASBESTOS CONTAINING MATERIALS AT ST JOHN OF GOD RICHMOND HOSPITAL, 177 GROSE VALE ROAD, NORTH RICHMOND NSW

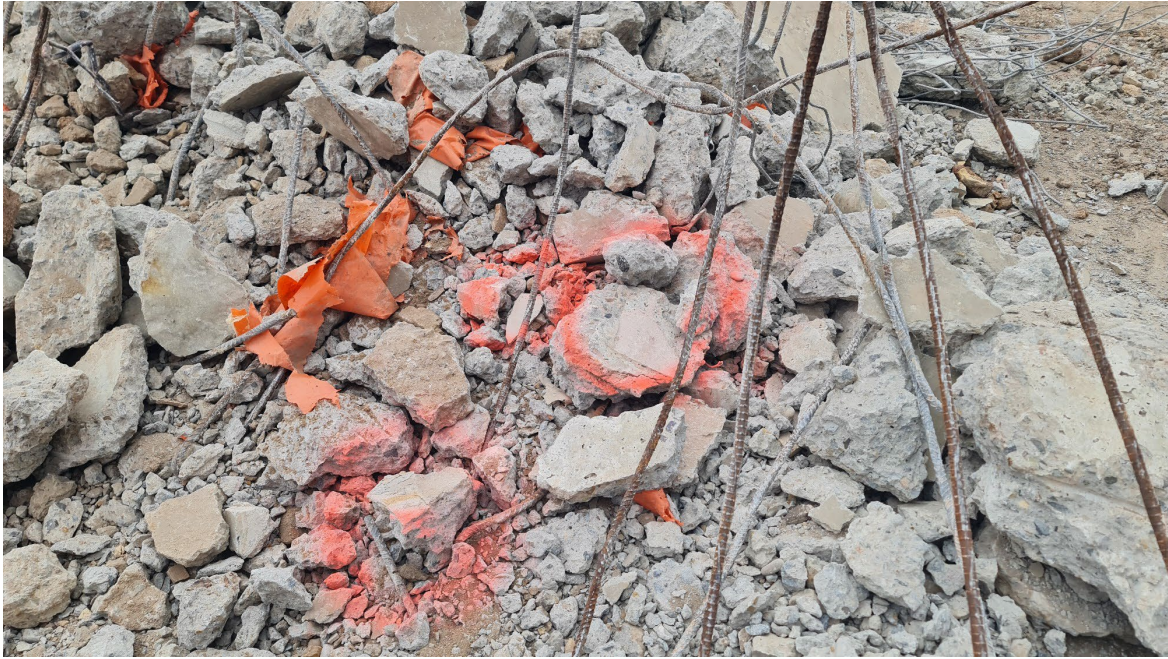
Sample 2, Education Centre – Asbestos cement sheet in underside of concrete slab (embedded in concrete and loose on ground) – **Chrysotile asbestos detected.**

**Sample 2 – Asbestos cement sheet material embedded on concrete floor slab
of the Education Centre building – Contains chrysotile asbestos**

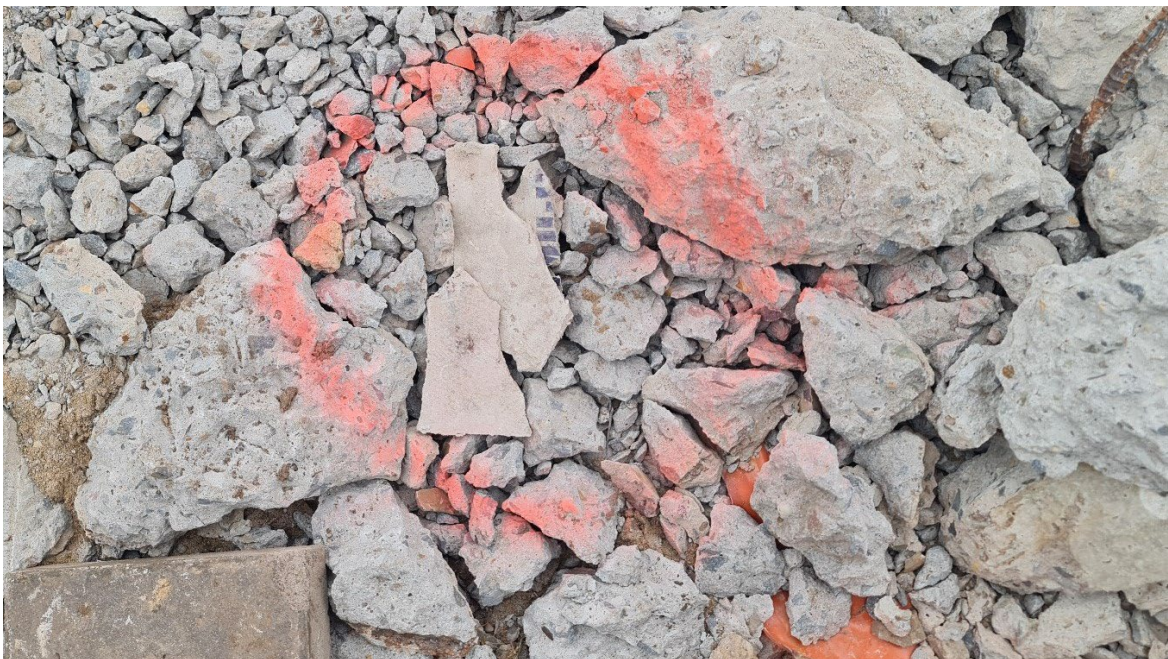
**Sample 2 – Asbestos cement sheet material found below concrete floor slab
of the Education Centre building – Contains chrysotile asbestos**

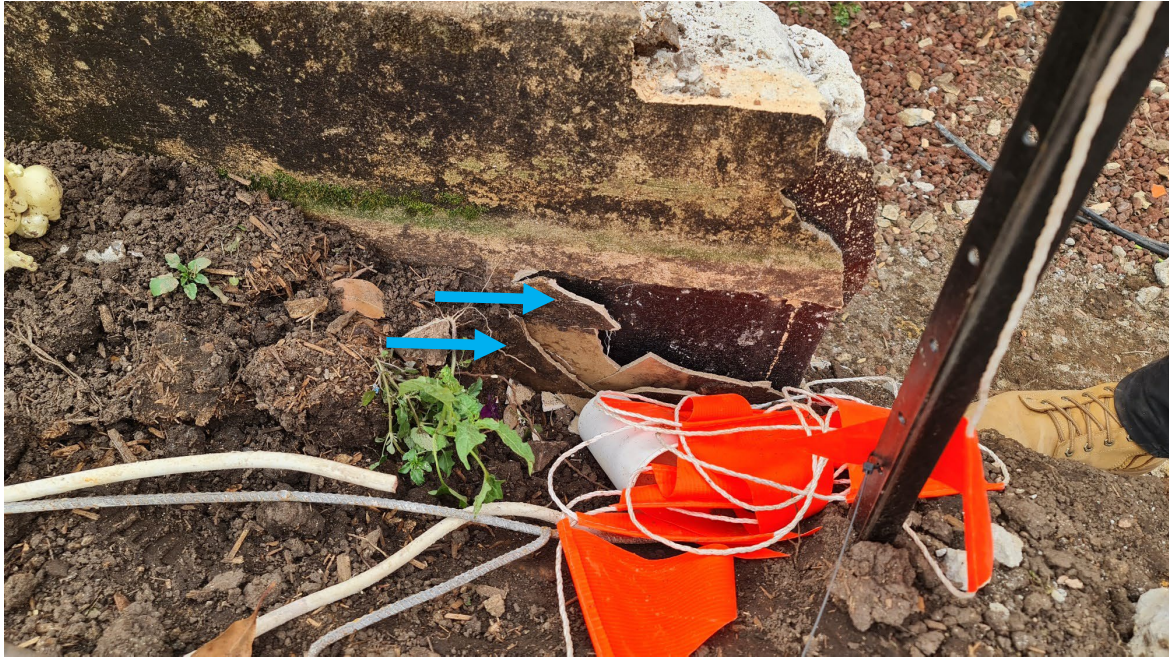
Sample 3, Retaining wall near Medical Centre – Two layers of fibrous cement sheet behind retaining wall – No asbestos detected.

**Sample 3 – Two layers of fibrous cement sheet behind retaining wall.
A composite sample of these materials was found to be free of asbestos**
