6 October 2022

**RE: REMOVAL OF ASBESTOS CONTAMINATED DEBRIS IN FILL SOIL  
BEHIND RETAINING WALL AT REAR OF FORMER MONASTERY BUILDING AT ST JOHN  
OF GOD RICHMOND HOSPITAL, 177 GROSE VALE ROAD, NORTH RICHMOND NSW**

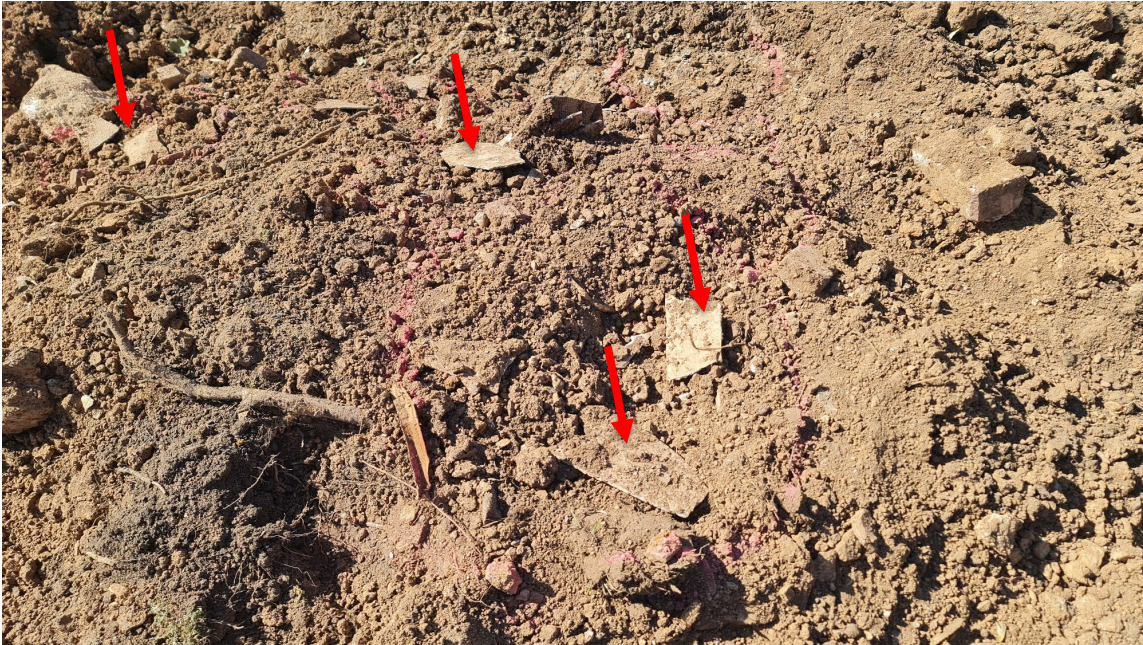
**Asbestos cement sheet debris in fill soil located behind the retaining wall at the rear of the former Monastery Building**

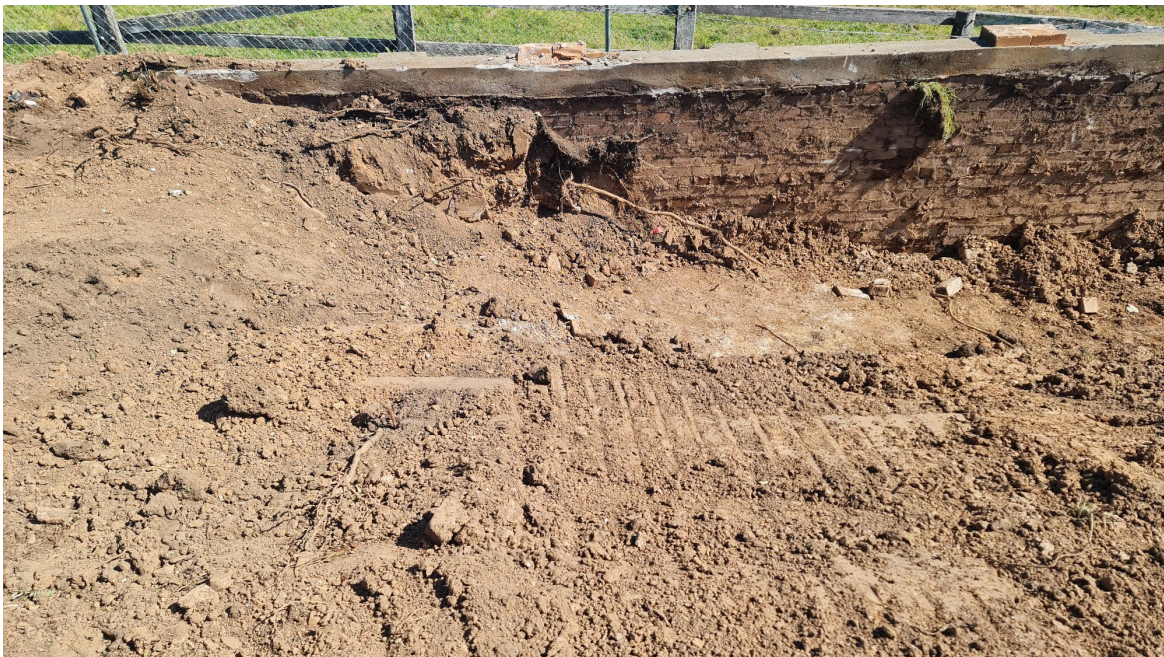
**Brick retaining wall at the rear of the former Monastery Building.  
Fill removed from the area where the wall is exposed and fill soil remaining  
against the wall contains fragments of asbestos cement sheet debris**
