28 October 2022

**RE: ASBESTOS CONTAMINATED SOIL REMOVAL CLEARANCE CERTIFICATION  
EXCAVATED SOIL ADJACENT TO RETAINING WALL ON SOUTH SIDE OF FORMER  
MONASTERY BUILDING AT THE ST JOHN OF GOD RICHMOND HOSPITAL  
177 GROSE VALE ROAD, NORTH RICHMOND NSW**

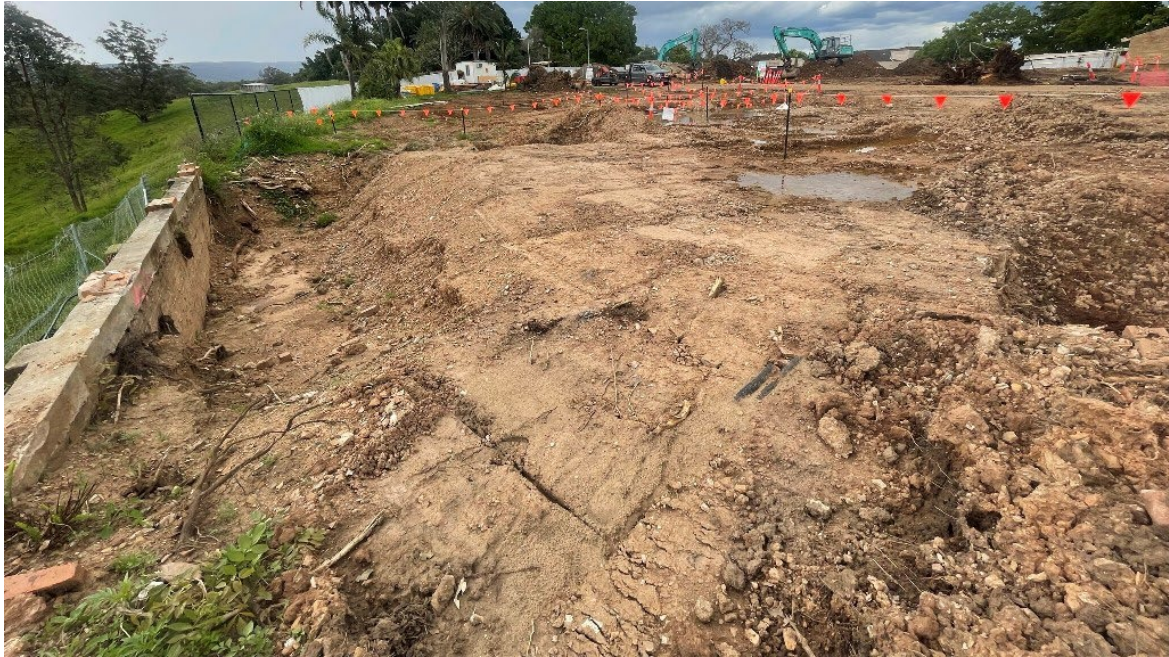
A second walkover was then carried out in an east / west direction also at an interval of approximately two metres. This visual inspection found the exposed surface soil within and surrounding this excavated area, to be free of visible asbestos containing materials such as fragments of asbestos cement. See attached photograph No. 1 in Appendix 1.

**Excavated area at the rear of the former Monastery Building on 27 October 2022  
at the completion of the removal of asbestos contaminated fill soil**

The former Monastery Building excavation area may now be accessed without the use of asbestos PPE for construction work to be carried out.

During future excavation in this area where fill soil remains, some isolated fragments of asbestos containing material may be identified. Should this occur these pieces of asbestos containing material are to be collected and bagged for disposal as asbestos contaminated waste.

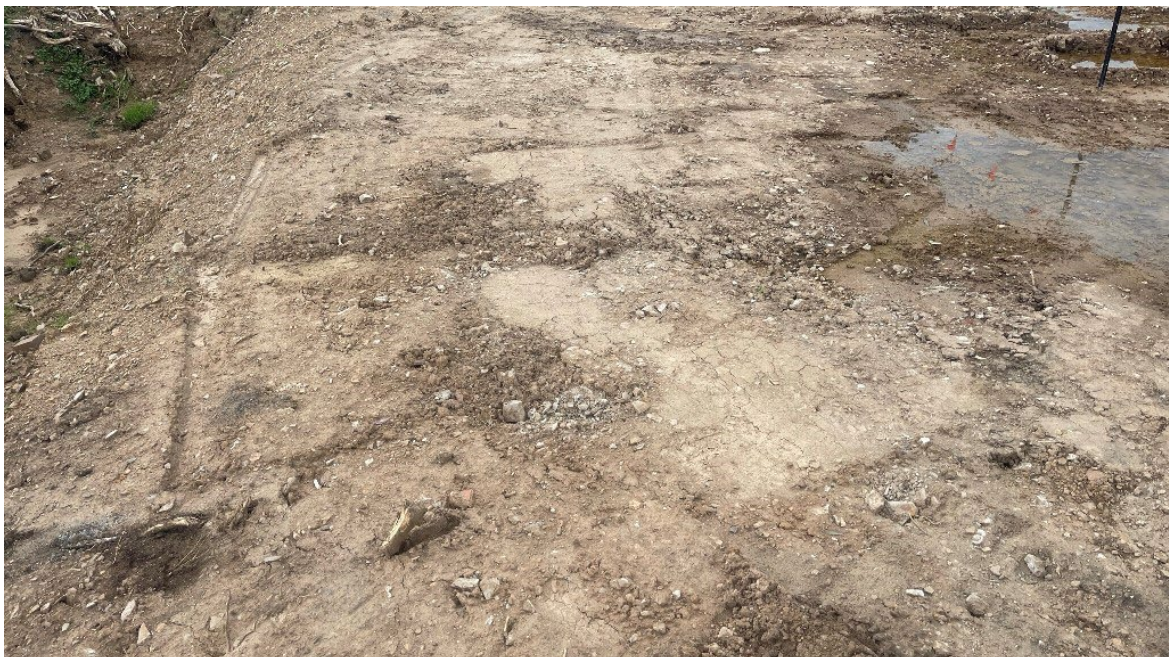
**Base of the excavated area at the rear of the former Monastery Building on 27 October 2022  
at the completion of the removal of asbestos contaminated fill soil**
