26 September 2022

**RE: ASBESTOS REMOVAL CLEARANCE CERTIFICATION FOR THE ASBESTOS
BACKED SHEET VINYL IN THE ST AUGUSTINES BUILDING AT THE ST JOHN
OF GOD RICHMOND HOSPITAL, 177 GROSE VALE ROAD, NORTH RICHMOND NSW**

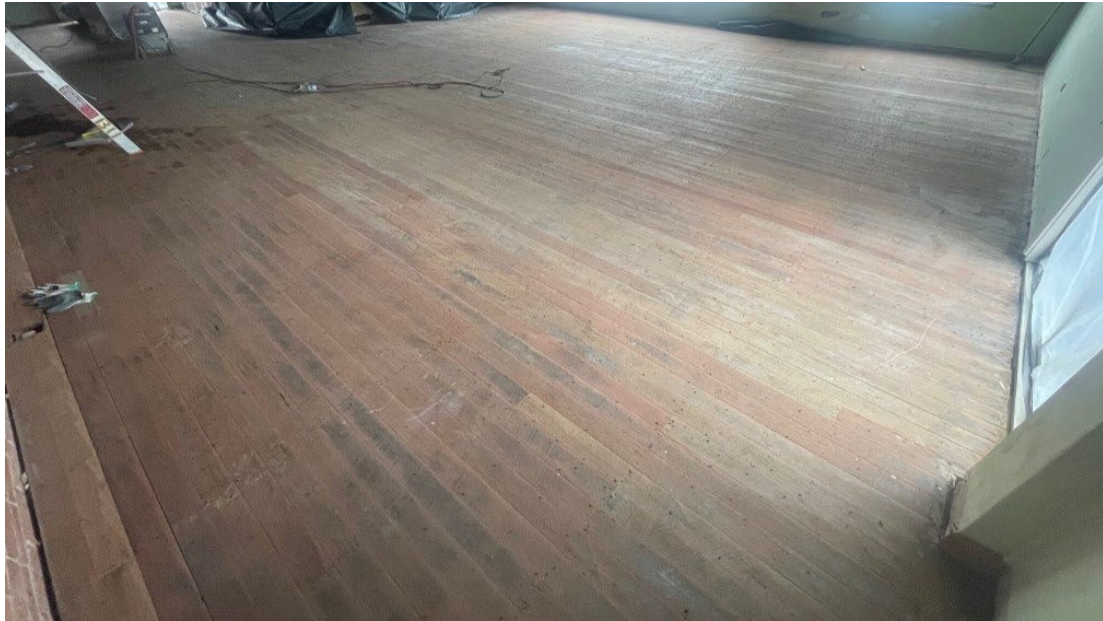
The timber flooring remaining in the large rear room was found to be free of visible asbestos containing material debris from the work. See attached photographs.

Timber floor in the large rear room in the St Augustines building at St John of God Richmond Hospital, 177 Grose Vale Road, North Richmond NSW at completion of visual clearance inspection on 23 September 2022

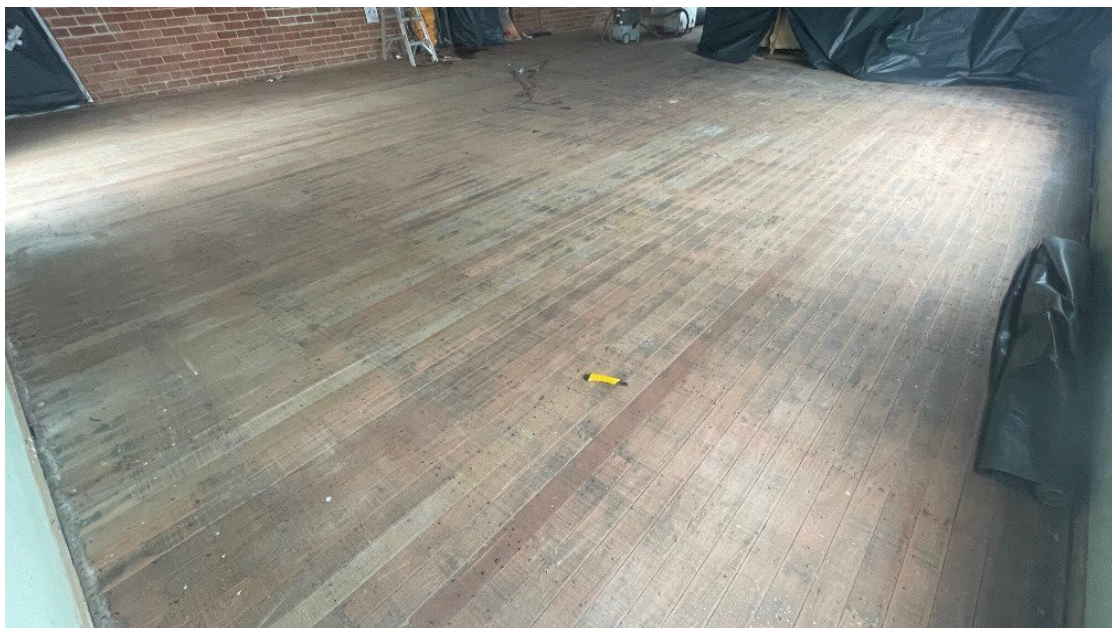
Timber floor in the large rear room in the St Augustines building at St John of God Richmond Hospital, 177 Grose Vale Road, North Richmond NSW at completion of visual clearance inspection on 23 September 2022
