**RE: REMOVAL OF ASBESTOS CONTAMINATED CONCRETE AND DEBRIS IN THE LOCATION OF THE FORMER STORE ROOM (MORTUARY) ADJACENT TO THE CTC BUILDING AT ST JOHN OF GOD RICHMOND HOSPITAL, 177 GROSE VALE ROAD, NORTH RICHMOND NSW**

**PHOTOGRAPH**

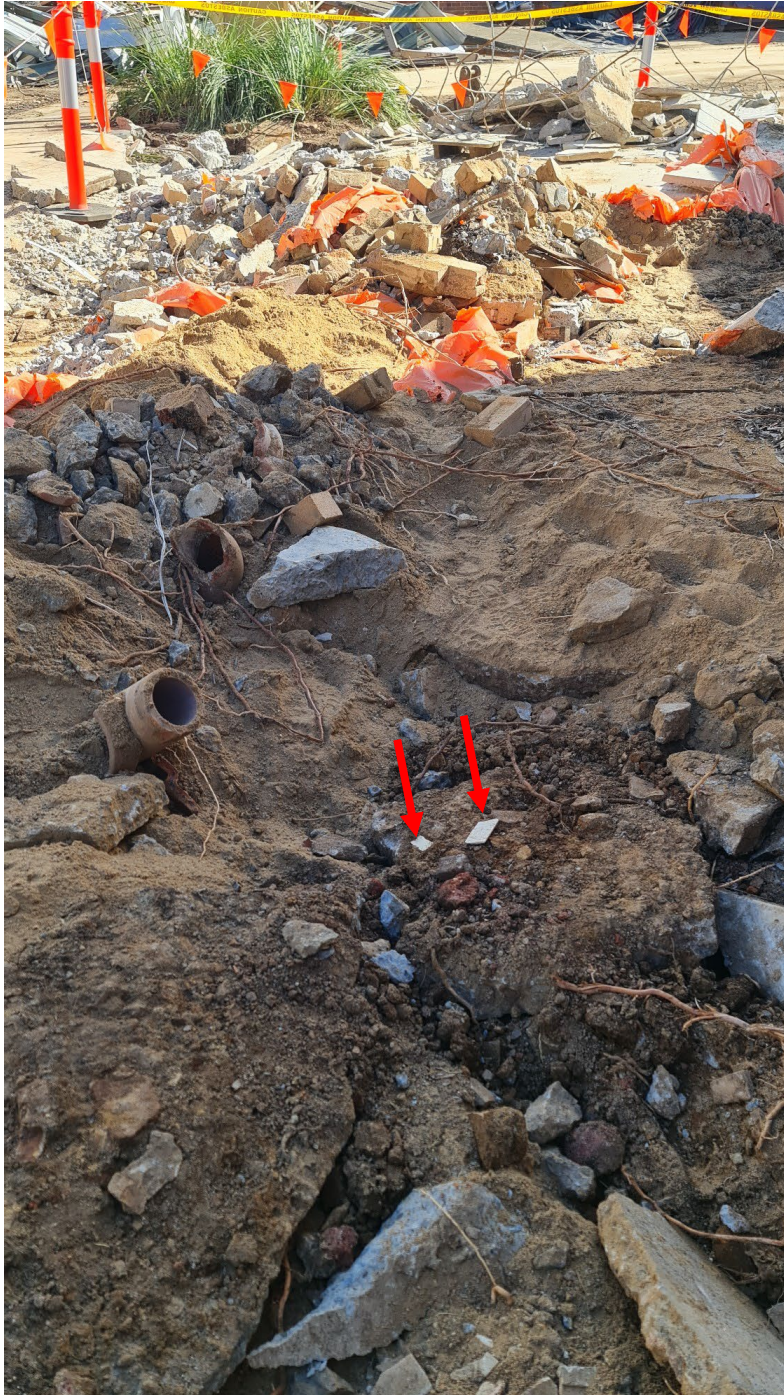
During demolition of the concrete floor slab, pieces of asbestos cement sheet have been found embedded at regular intervals in the underside of the concrete slab which are presumed to be supports for the chairs holding the reinforcing steel within the slab. Upon removal of parts of the slab, loose pieces of asbestos cement sheet have been found on the ground surface and in the fill soil below the slab.

Analysis of the sampled material confirmed it to contain chrysotile asbestos. See sample 1 on the attached laboratory report.

**Asbestos contaminated concrete and soil in the area of the former store room (mortuary) adjacent to the CTC building. The asbestos cement debris in this area contains chrysotile asbestos**

6. The concrete slab pieces with embedded asbestos cement sheet debris is to be broken up and loaded into plastic lined skip bins or trucks and transported for disposal as non-friable asbestos contaminated waste at a landfill facility licenced by the NSW EPA to accept the waste soil. Concrete without embedded asbestos cement sheet I to be disposed of as clean demolition waste.

7. After all of the concrete has been removed, the loose fragments of asbestos cement sheet debris are to be collected and bagged for disposal as asbestos waste.

8. The fill soil containing fragments of asbestos cement sheet debris and concrete debris is to be scrapped to remove all concrete and asbestos cement sheet debris. Scrapping is to be undertaken in layers of 50mm or so until no further asbestos cement sheet debris.
