25 August 2022

RE: ASBESTOS REMOVAL CLEARANCE CERTIFICATION FOR THE COVERED WALKWAY BETWEEN CTC BUILDING AND BELMONT HOUSE AT THE ST JOHN OF GOD RICHMOND HOSPITAL, 177 GROSE VALE ROAD, NORTH RICHMOND NSW

PHOTOGRAPH

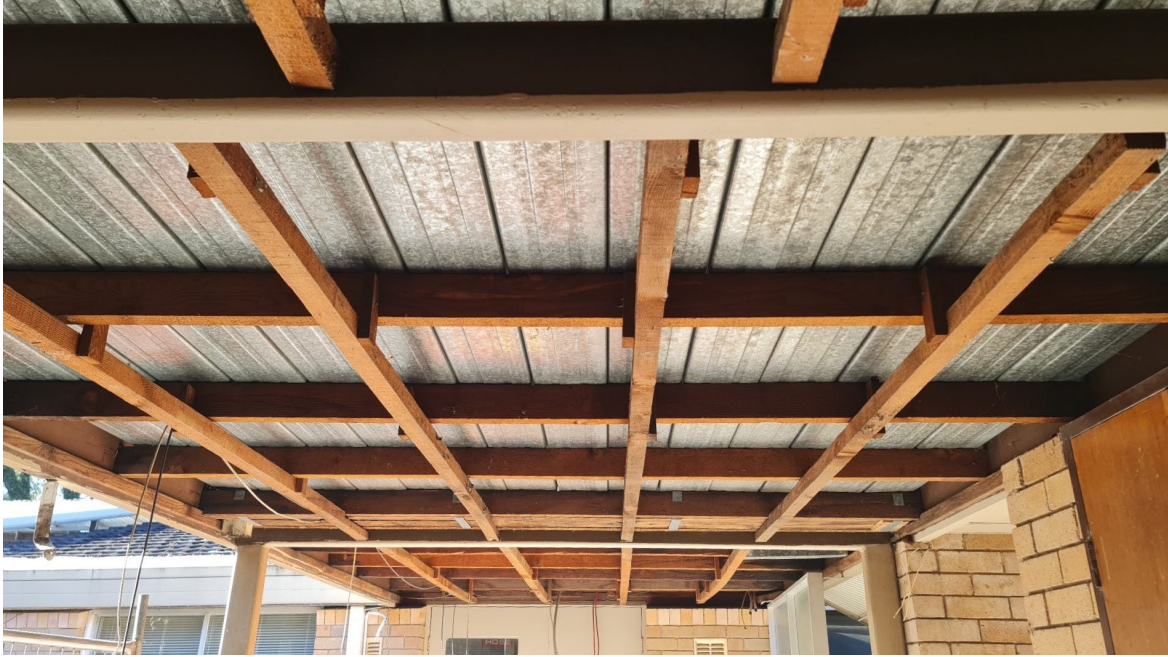
The visual inspection undertaken on 24 August 2022 found all of the flat asbestos cement sheet soffit lining to have been removed from the covered walkway roof. See attached photograph.

The timber framing from which this lining materials was removed and the floor of the covered walkway and adjacent ground areas were found to be free of visible asbestos containing material debris from the work.

Timber framing to the covered walkway extending between the CTC Building and Belmont House at St John of God Richmond Hospital, 177 Grose Vale Road, North Richmond NSW at completion of visual clearance inspection on 24 August 2022

Based on the findings of the visual clearance inspection which found all of the asbestos cement sheet soffit lining to have been removed, we confirm that this walkway area within the Richard Crookes Constructions site area at the St John of God Richmond Hospital at 177 Grose Vale Road, North Richmond NSW may be safely accessed without the use of asbestos PPE for demolition work to be undertaken.
